BUILDING DAMAGE DUE TO 2008 WENCHUAN EARTHQUAKE AND COOPERATIVE ACTIVITIES ON DAMAGE RESTORATION BY JAPANESE EXPERTS

Keywords: Sichuan (Wenchuan) Earthquake, Damage Restoration, Technical Support Liaison Council

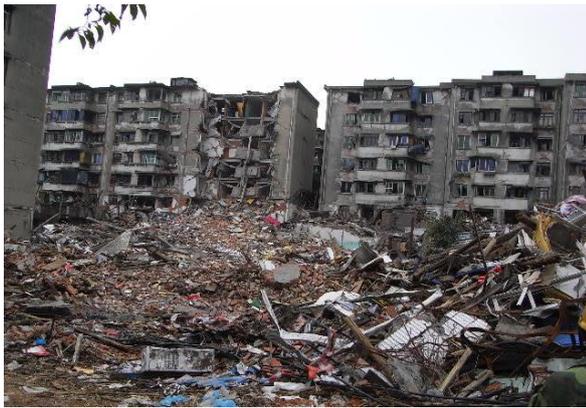
Photo 1 Seriously Damaged Brick Buildings (Hanwang town of Mianzhu city)

Brick buildings are most seriously damaged and they often sustain partial or total collapse, resulting in the primary source of human damage. They have UR brick walls having RC ring beams and precast concrete hollow-core slabs above the walls. The major cause of the fatal damage is attributed to the low resistance and brittleness of URM walls and poorly detailed joints between precast concrete members and RC beams. Photos 1 and 2 show typical damage to brick buildings.

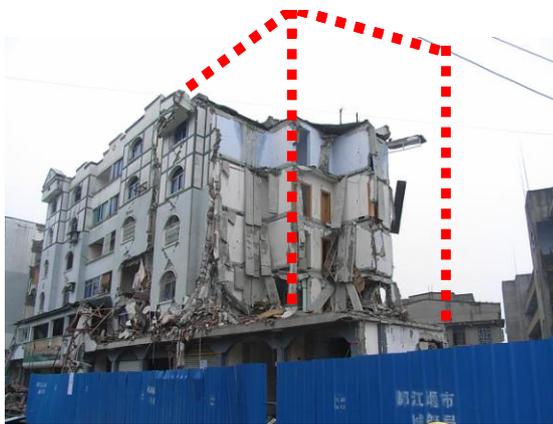
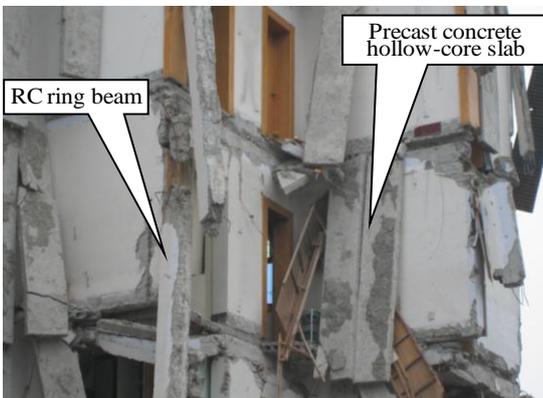
Photo 2 Partially Collapsed Brick Buildings with Precast Concrete Hollow-core Slabs (Dujiangyan City)

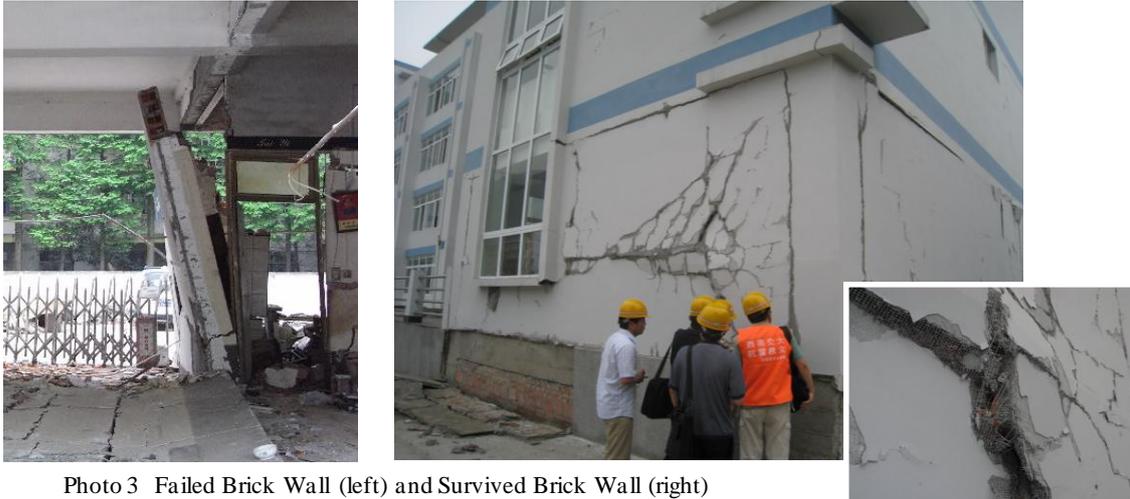
Reinforced concrete shear walls are much less frequently provided in RC buildings than UR brick walls. Lightly reinforced small-sized columns (tie columns) are often placed later between UR brick walls so that the walls should serve as the form in casting concrete of RC tie columns. During the surveys, shear cracks and failure of brick walls are found in many buildings as shown in Photo 3. It should be noted, however, that lath-mortar finishing on the exterior surface of UR brick walls is found to help avoid their out-of-plane failure, although they are heavily cracked. Such efforts therefore should be encouraged to minimize falling hazard to residents and users during and after major earthquakes.

Photo 3 Failed Brick Wall (left) and Survived Brick Wall (right)

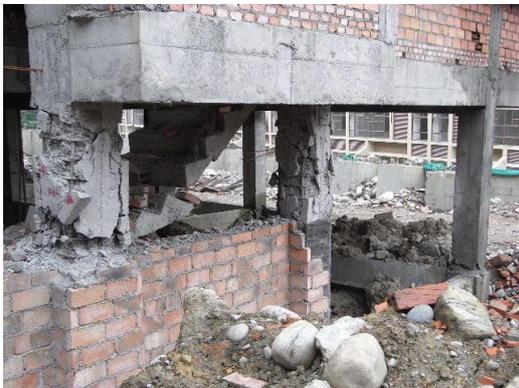
Photo 4. Typical shear failure in RC short columns

have been found elsewhere in the past damaging earthquakes. Photo 4 shows a typical shear failure in the first story of a building in Dujiangyan city. Photo 5 shows another failure, where the column is shortened and failed in shear leaving vertical cracks along the interface between the column and brick wall. The damage is attributed to the presence of partial height brick walls, which are generally neglected in the structural design but significantly affect the building's behavior during strong shaking.

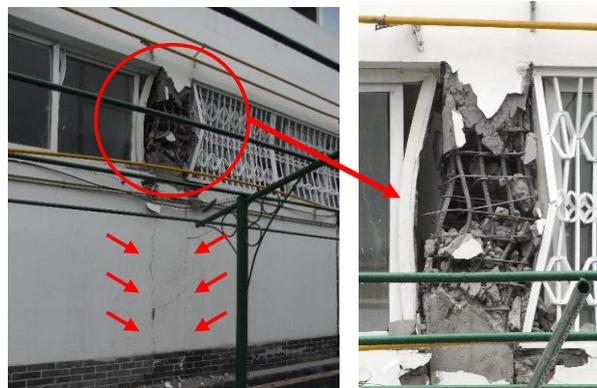
Photo 5. Shear failure in RC column shortened by partial height brick wall

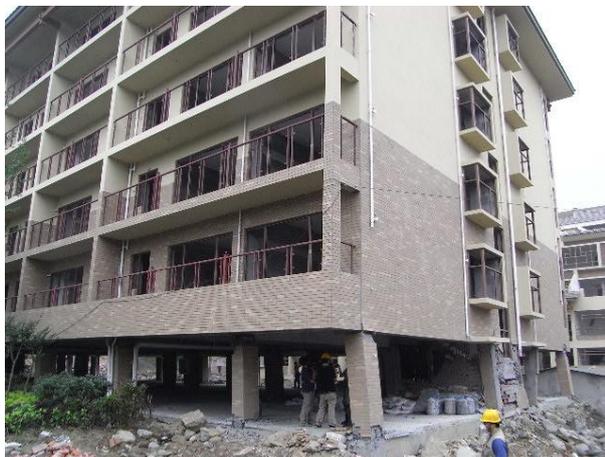
Photo 6 General view of a six story RC apartment house

Seriously damaged RC buildings often show flexural compression failure at the top and bottom of their columns. Photos 6 and 7 show the damage to columns in the first story of a six story apartment building in Dujiangyan city. Hooks of lateral reinforcement are pulled out of crushed concrete core. Main rebars buckle and fracture as shown in the photos. As will be found later in this paper, the building is employed for a sample building to investigate possible restoration schemes and to discuss their feasibility with Chinese engineers.

Almost all columns in the first story form plastic hinges both at their top and bottom, causing concrete crushing and rebar buckling (Photos 6 and 7) resulting in the soft first story mechanism with a residual lateral drift of approximately 10% of the story height. No major damage is, however, found in upper stories.

The observed damage is rated [unsafe] based on the Japanese post-earthquake quick inspection manual (JBDPA1997) and [heavy damage] based on the Japanese post-earthquake damage evaluation guidelines (JBDPA 2001, Nakano et al. 2004). The building therefore is identified to be [no occupancy] and needs to be shored to avoid life-threatening risk and further damage progress due to aftershocks.

Scheme 1 aims primarily to repair the damaged columns after re-centering the building, replacing buckled rebars with new rebars, and re-cast concrete in the damaged region. Since the performance may not be fully recovered to the original due to extensive damage and hence the seismic capacity index I_s after restoration ($\psi=0.7$ assumed) is lower than the original value of 0.67, the restored building is likely to collapse when subjected to the future shaking with intensity similar to the main event on May 12.

Scheme 2 aims to repair and upgrade flexural strength and confinement of columns by RC jacketing after re-centering the building. In Scheme 2, the flexural strength after restoration is estimated neglecting reinforcement in the original section, which is found buckled in the survey, while the whole section including repaired inner (i.e., original) section is assumed effective on the shear strength. As is found in Table 2, the expected performance may be better than the original, but both Schemes 1 and 2 need re-centering of the building, which may not be necessarily easy and requires well-experienced engineers with high-level skills.

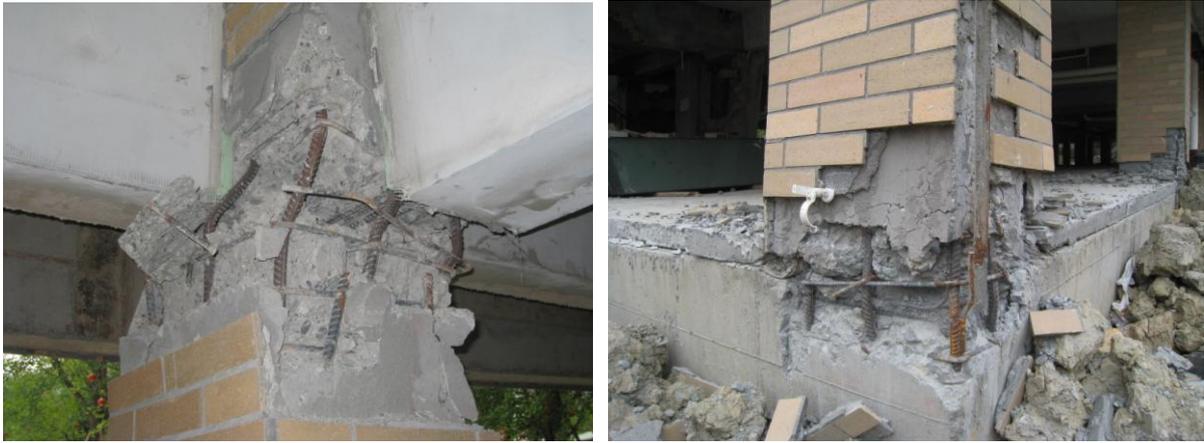
Photo 7 Flexural Compression Failure at the top and Bottom of Columns

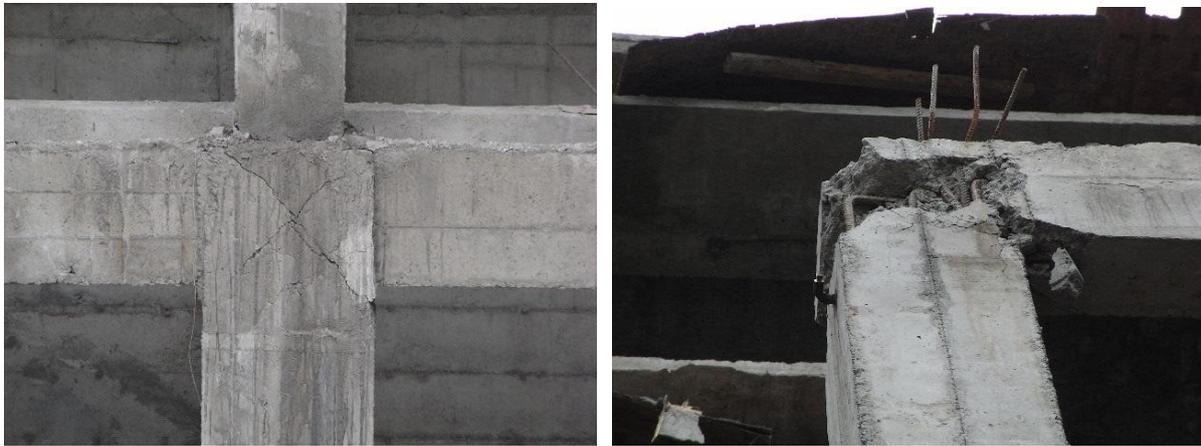
Damage to beam-column joints are less frequently found than other failure patterns such as shear failure in columns, flexural compression failure in columns. Photo 8 shows the damage to beam-column joints of RC apartment buildings, which were under construction at the time of the earthquake.

Photo 8 Failure in beam-column joint

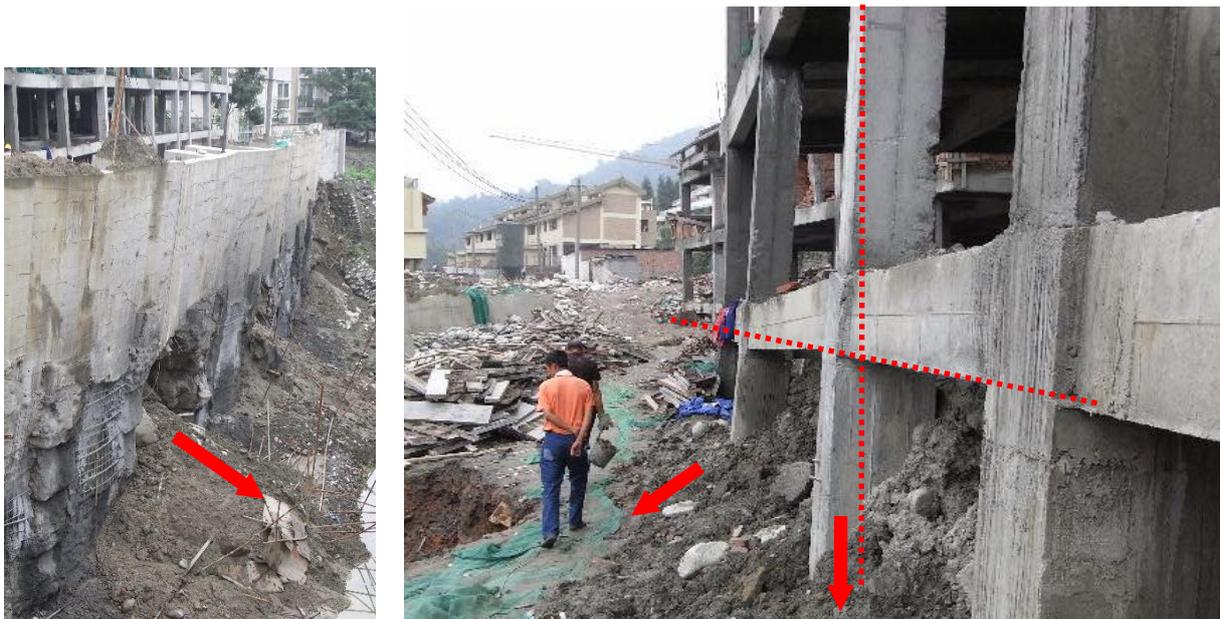
Photo 9. Structural damage due to failure in retaining wall

in Dujiangyan city. Photo 9 shows damage to a retaining wall, causing soil outflow and differential settlement of superstructures.

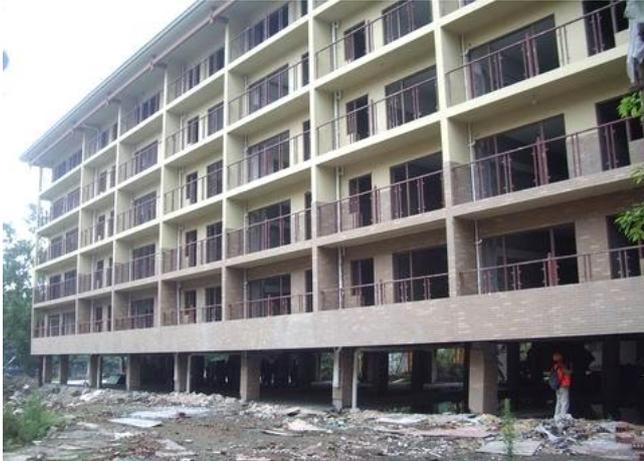
Photo 10 Example six story RC partment building (See also Photos 6 and 7)

The example building is a six story RC apartment building in Dujiangyan city, which appeared earlier in Photos 6 and 7. The building was under construction but its structural construction was already completed at the time of the earthquake. The first story designed for a parking garage has no walls, while the upper stories have dwelling units with UR brick walls as shown in Photo 10 and Figure 2.
