PERFORMANCE OF REINFORCED CONCRETE BUILDINGS IN THE 2016 KUMAMOTO EARTHQUAKES AND SEISMIC DESIGN IN JAPAN

ABSTRACT

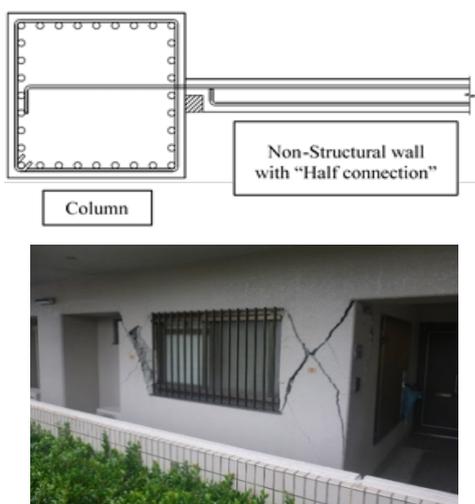
Figure 4: Typical non-structural wall connection and example of damage to non-structural wall (see Appendix A2).

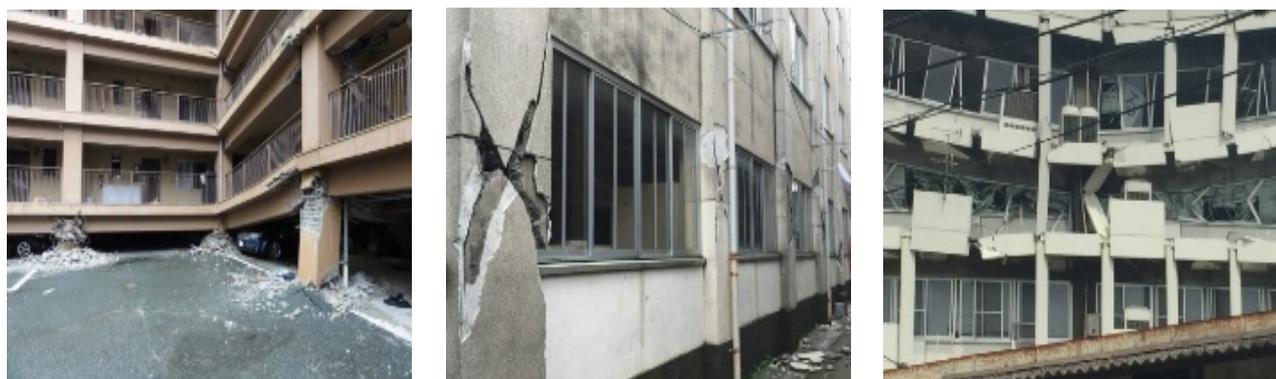
Figure 7: Examples of damage to pre-1980s concrete buildings.

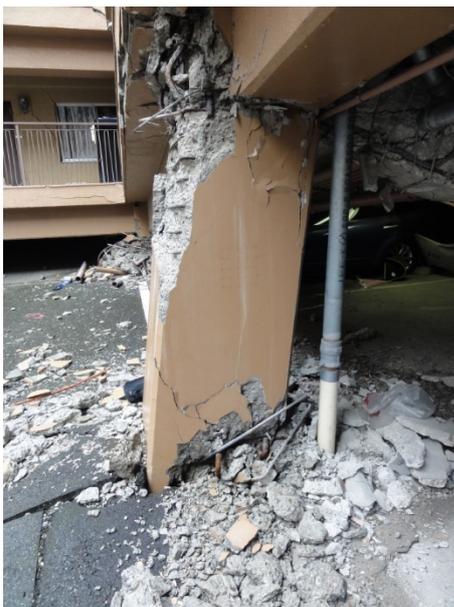
Photo 2

Note: base of column shear failure and joint failure (potentially induced as column pushed out by failure plane)

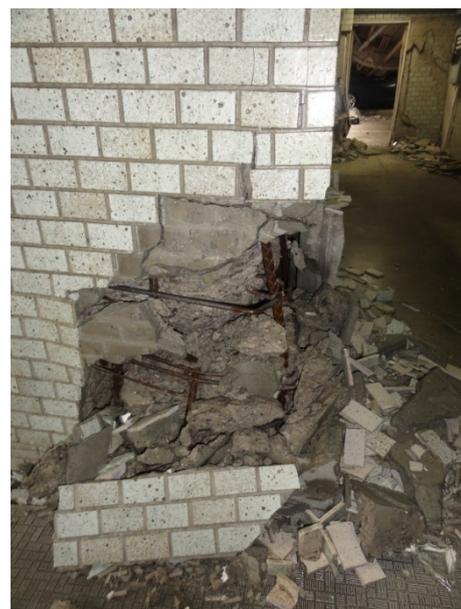
Photo 5a: crushed columns at corners of walls around core.

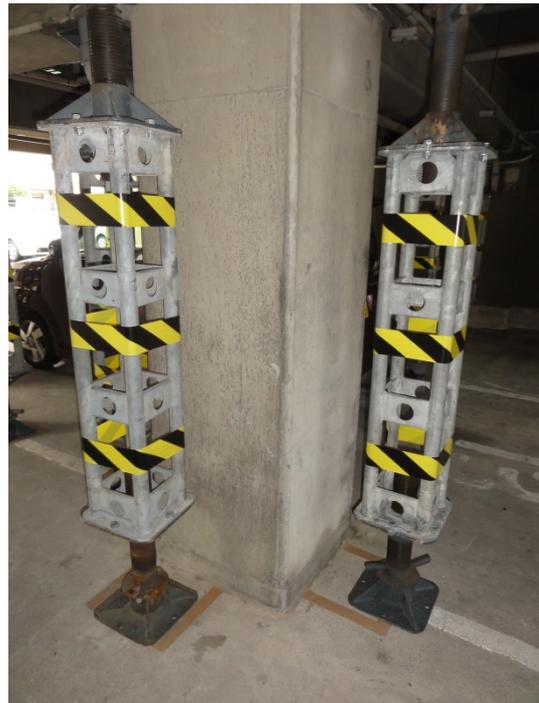
Photo 1: Bidirectional shear cracks.

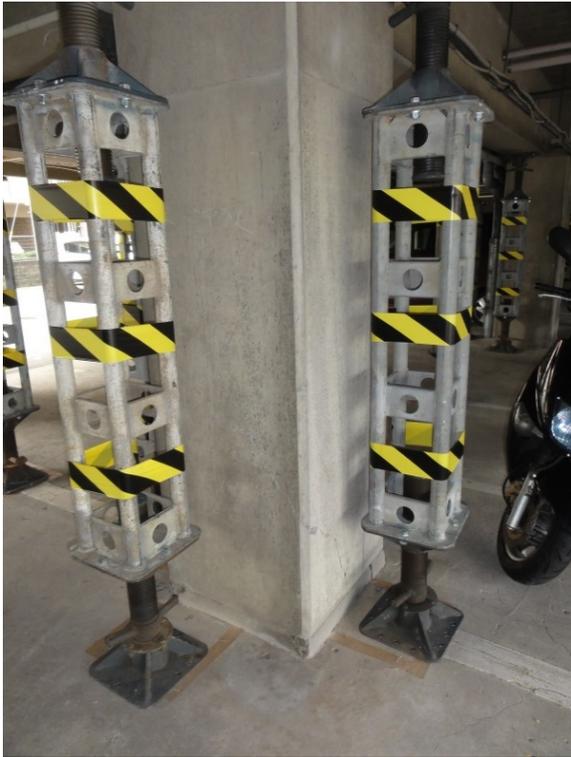
Photo 2: Bidirectional shear cracks.

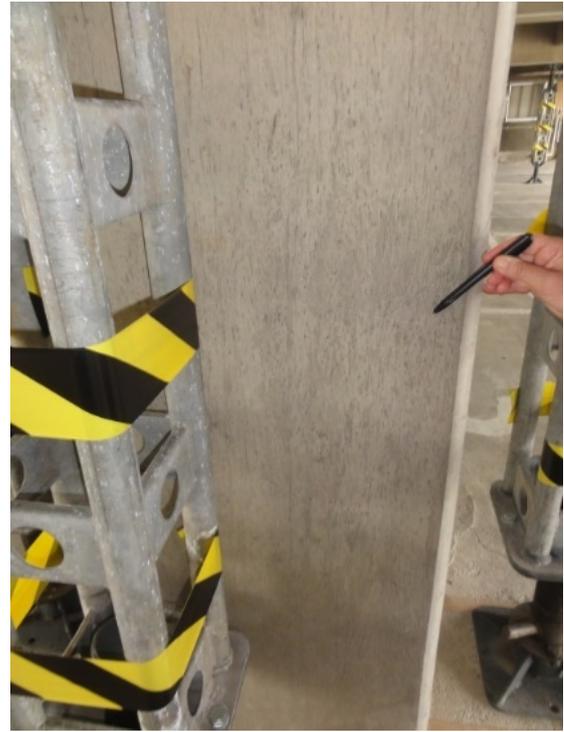
Photo 3b: Apparent torsional cracks.

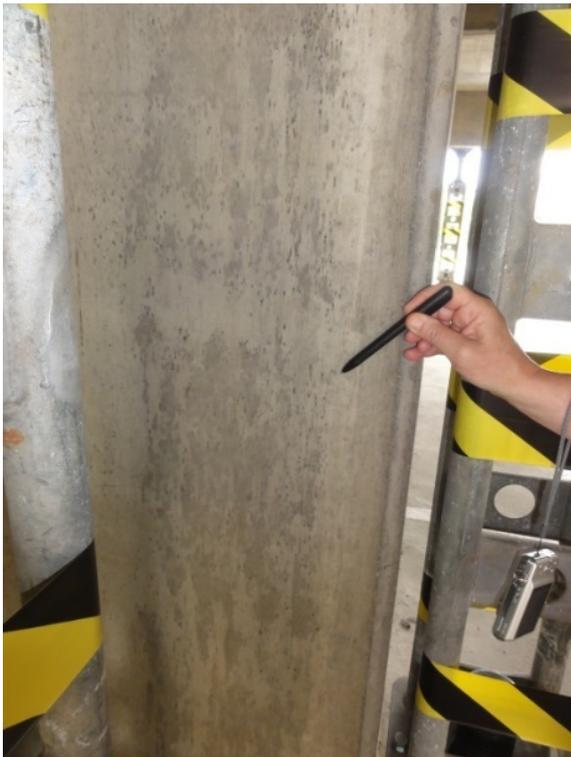
Photo 3a: Apparent torsional cracks.

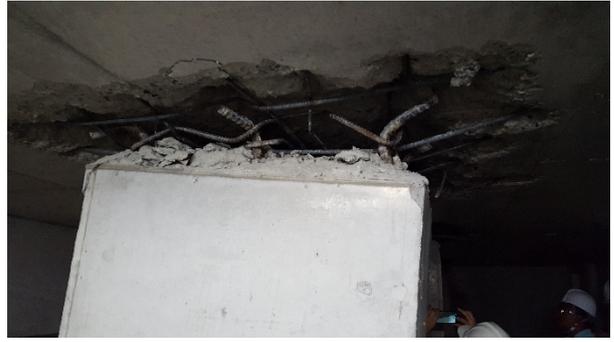
Photo 7: Failure at joint between floor slab & lead dampers.

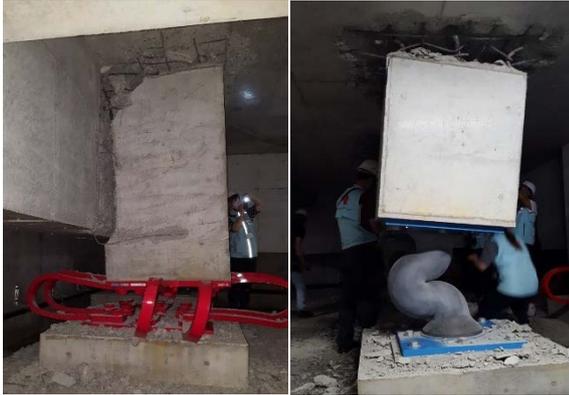
Photos 3 & 4: Separation of steel dampers from concrete beams.

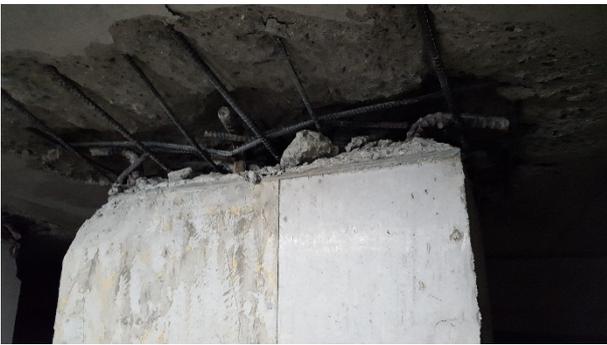
Photo 5: Failure at joint between floor slab & lead dampers.

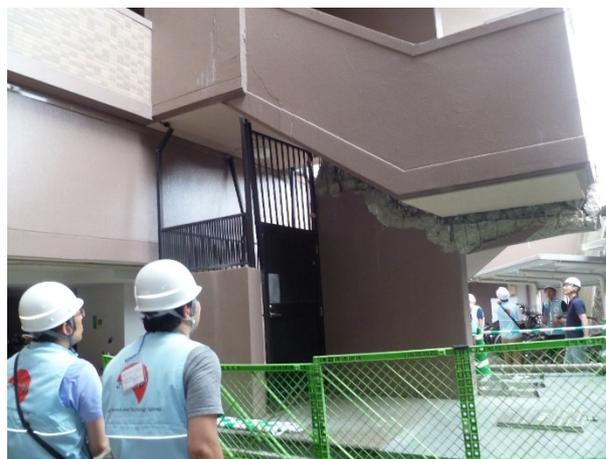
Photo 4: Damage to the first level of stairs on base isolated Building No.2. Staircase isolated at ground level while isolation plane of main structure was at level 1.

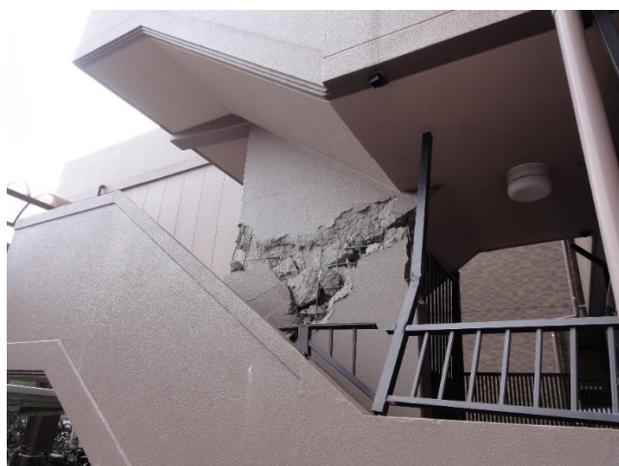
Photo 3: Damage to the first level of stairs on base isolated Building No.2. Staircase isolated at ground level while isolation plane of main structure was at level 1.

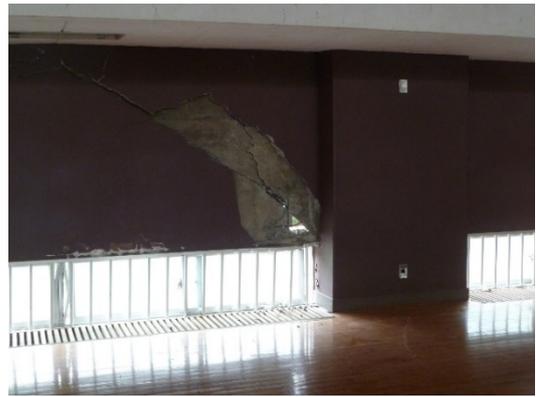
Photo 4: Shear cracking damage to concrete beam supporting mezzanine on side wall.

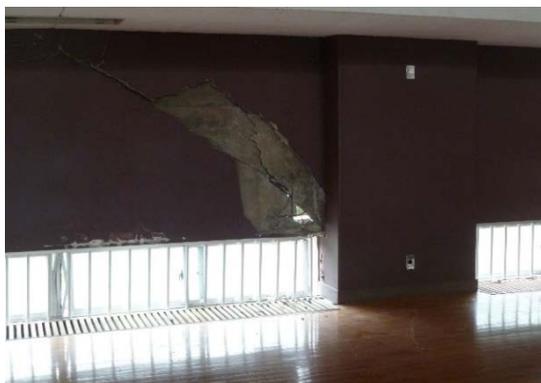
Photo 4: Shear cracking damage to concrete beam supporting mezzanine on side wall.

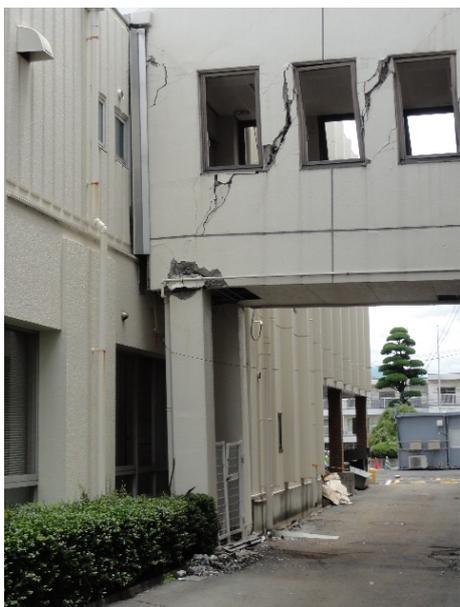
Photo 3: Damage to bridge between two buildings.

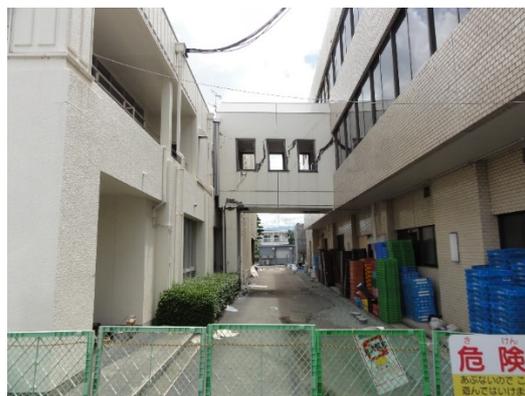
Photo 4: Damage to bridge between two buildings

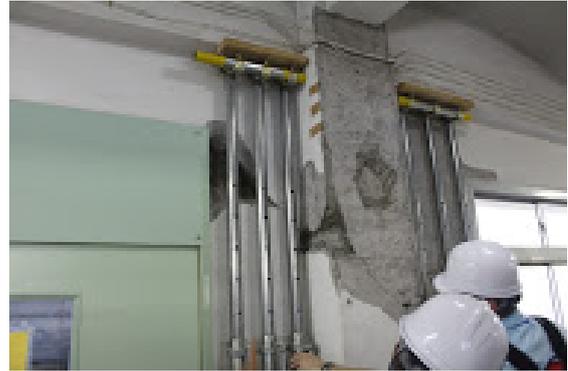
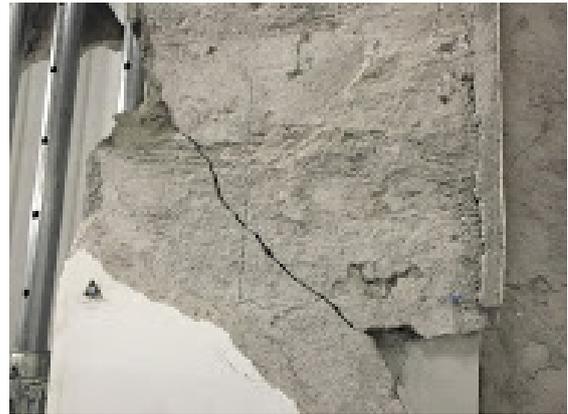
Photos 6 & 7: Shear damaged column (damage class IV) located in corridor 1st floor level.

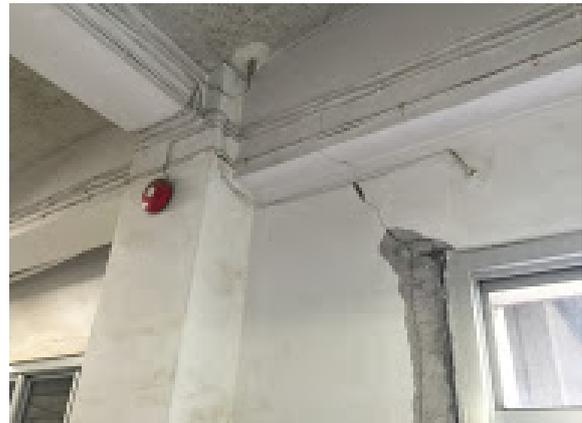
Photo 8: Typical damage to concrete “non-structural” walls between concrete moment frames.

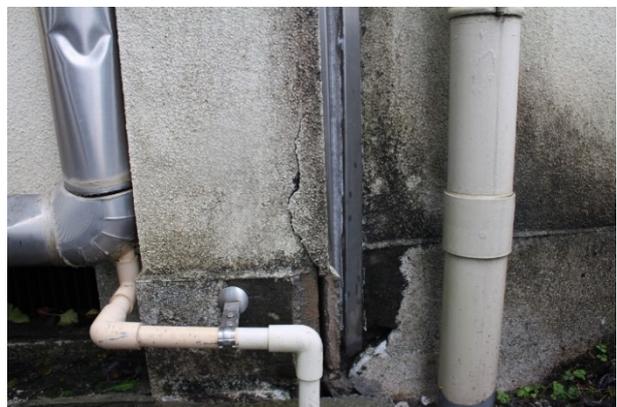
Photo 9: Pounding damage at seismic joint between classroom blocks.

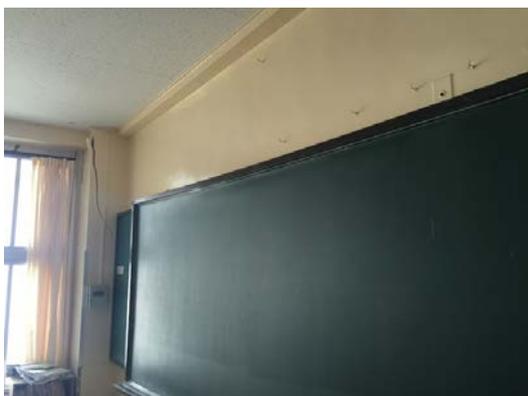
Photo 4: A rare instance of damage to the classroom side external columns.

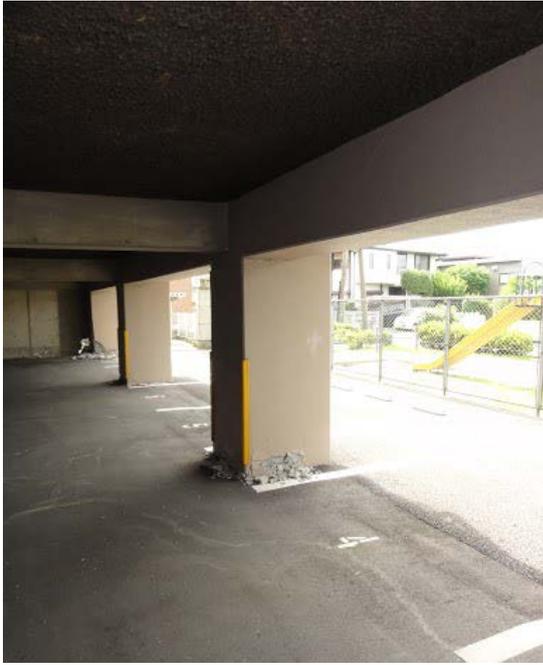
Photo 3: Damage to the columns on South side (most severe damage was to the far-east end column).

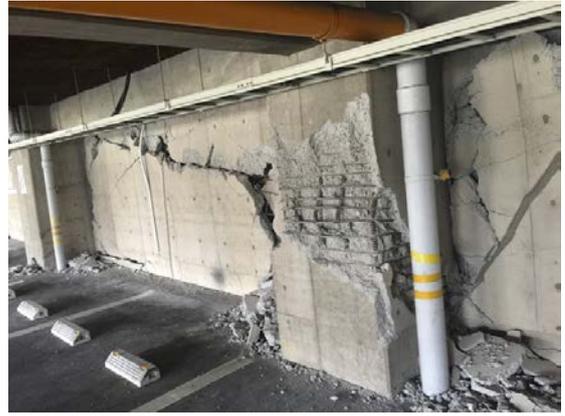
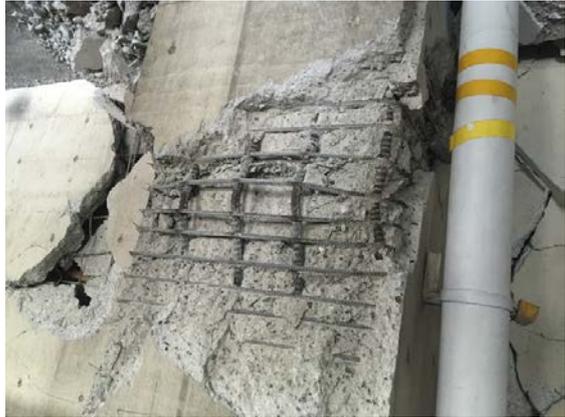
Photos 6 & 7: Close up view of typical columns failed in short column induced shear failure.

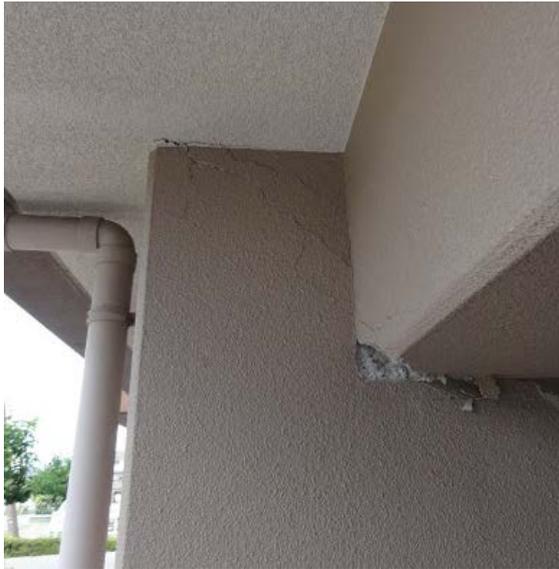
Photo 4: Damage to the central beam-column connection on the south frame.

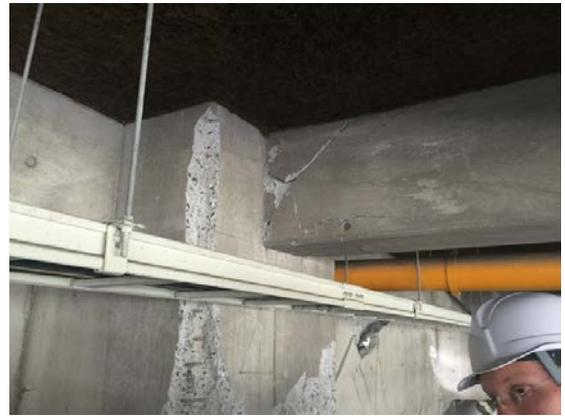
Photo 8: Beam-Column connection at the top of the shear damaged column.

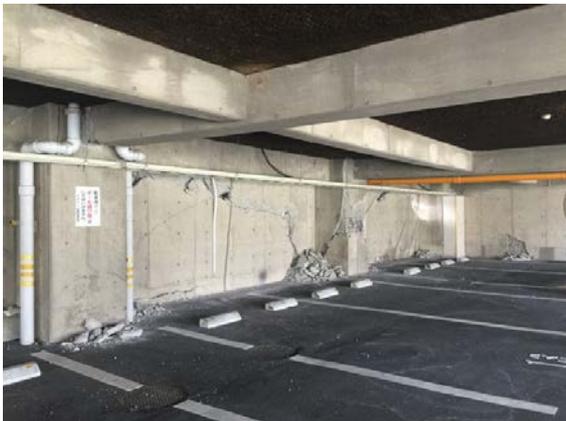
Photo 5: Damaged walls and column on the north side.

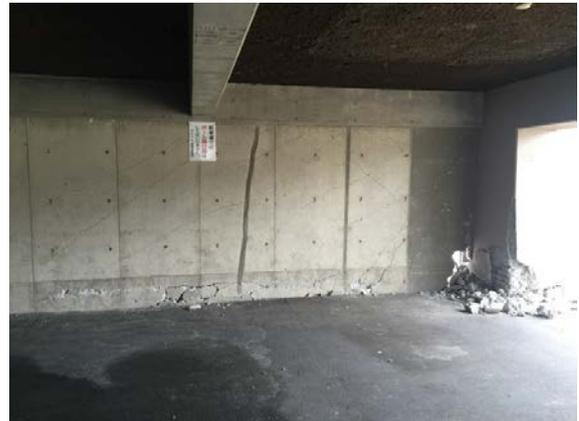
Photo 9: Shear cracks on the east side wall and damage to the south-east corner column.

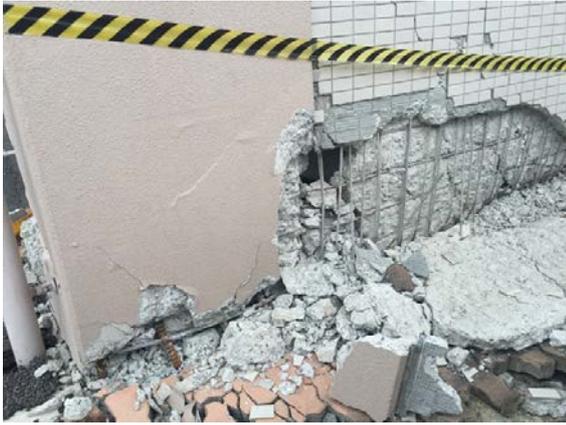
Photo 10: Damage to the SE Corner column and its connection to the adjacent East face wall (Photo taken from outside the building).

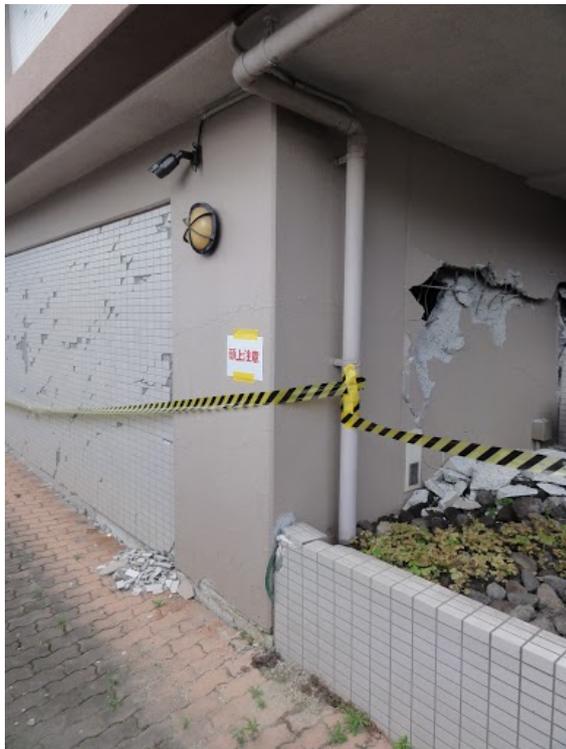
Photo 11: Damaged orthogonal walls at the NE corner (Photo taken from outside the building).

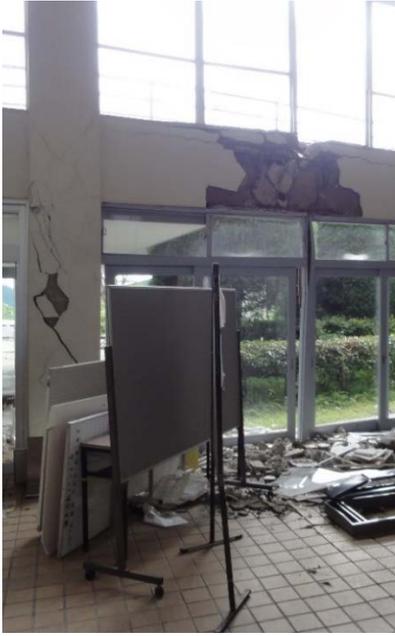
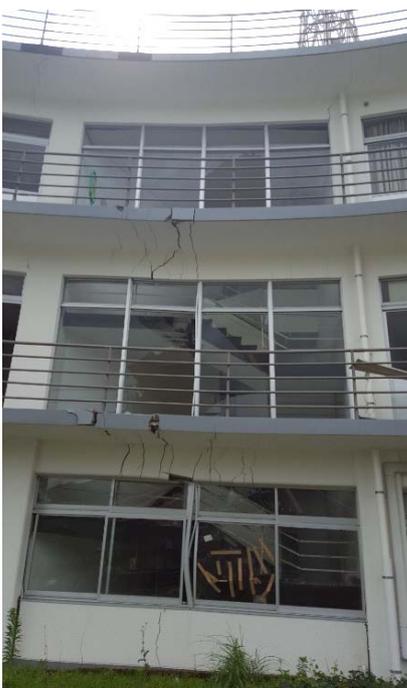
Photos 7, 8 & 9: Visible signs of damage at “Y” juncture of building.

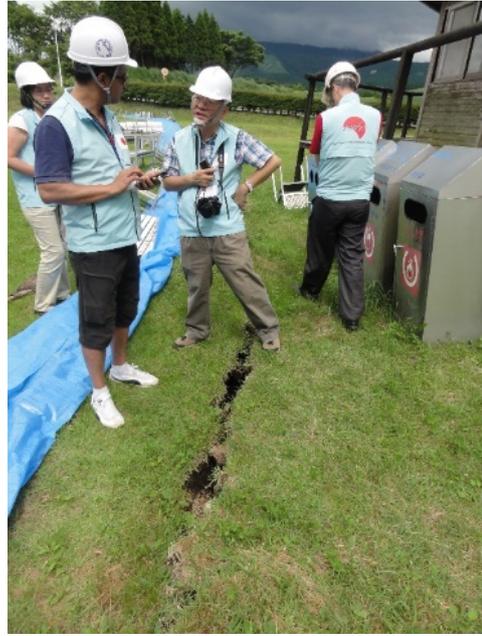
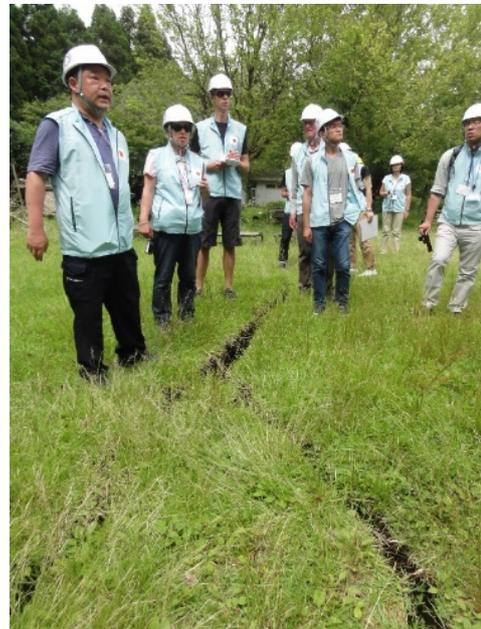
Photos 10 & 11: Cracks found throughout ground on both sides of the building.

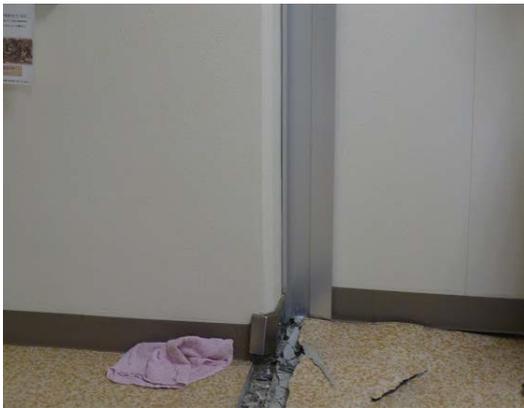
Detail B: Seismic joint between four storey block and interconnector at building interior showing some damage to floor at joint.

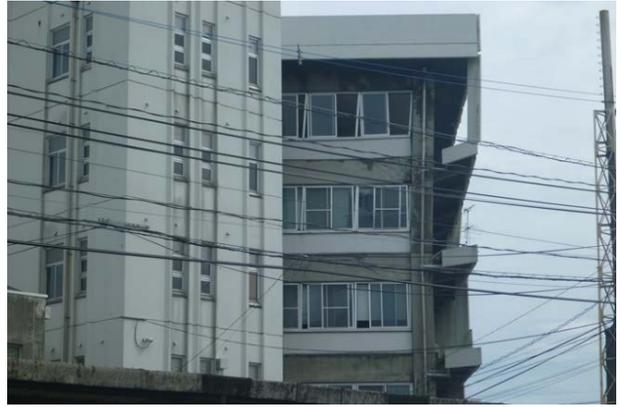
Photo 4: Beam plastic-hinges and permanent offset of upper floors.

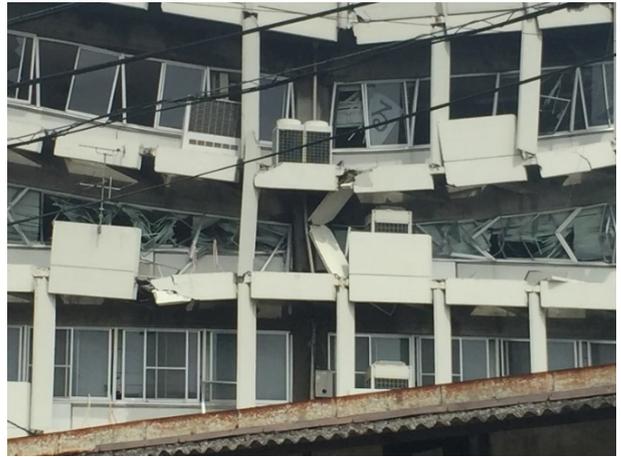
Photo 5: Beam-column joint shear failure and dislocation of beam from column.

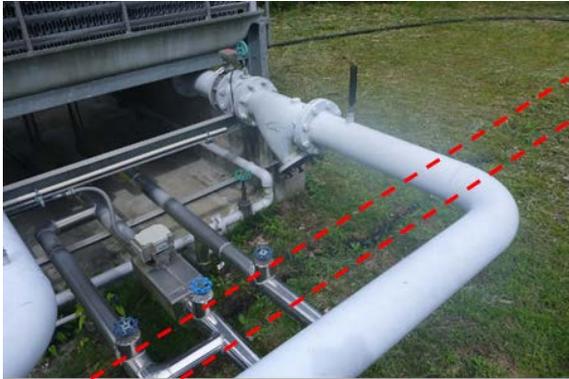
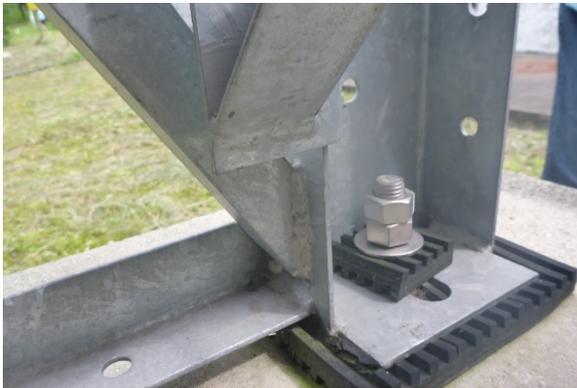
Photos 1 & 2: Building A14 major plant items located behind the teaching / office building.

- Ground rupture observed beside chillers (highlighted in above photos with dashed lines).
- No damage observed to plant or plant supports or connecting piping.
- The arrangement of major plant on the ground near the building was observed at many locations.

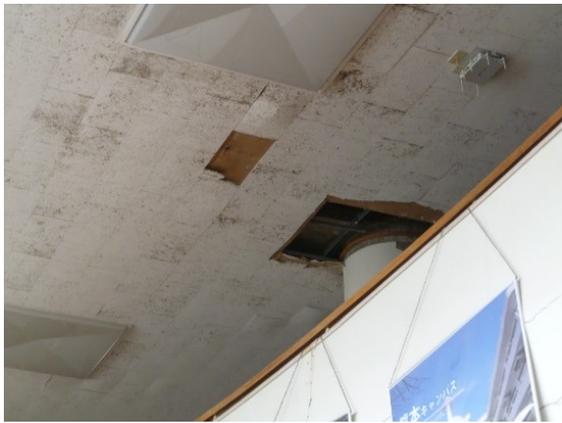
Photo 8: Building A13 interior ceiling damage.

- Localised damage to hung ceiling tiles adjacent to structural column penetrating ceiling.
