BUILDING DAMAGE DUE TO 2008 WENCHUAN EARTHQUAKE AND COOPERATIVE ACTIVITIES ON DAMAGE RESTORATION BY JAPANESE EXPERTS

Keywords: Sichuan (Wenchuan) Earthquake, Damage Restoration, Technical Support Liaison Council

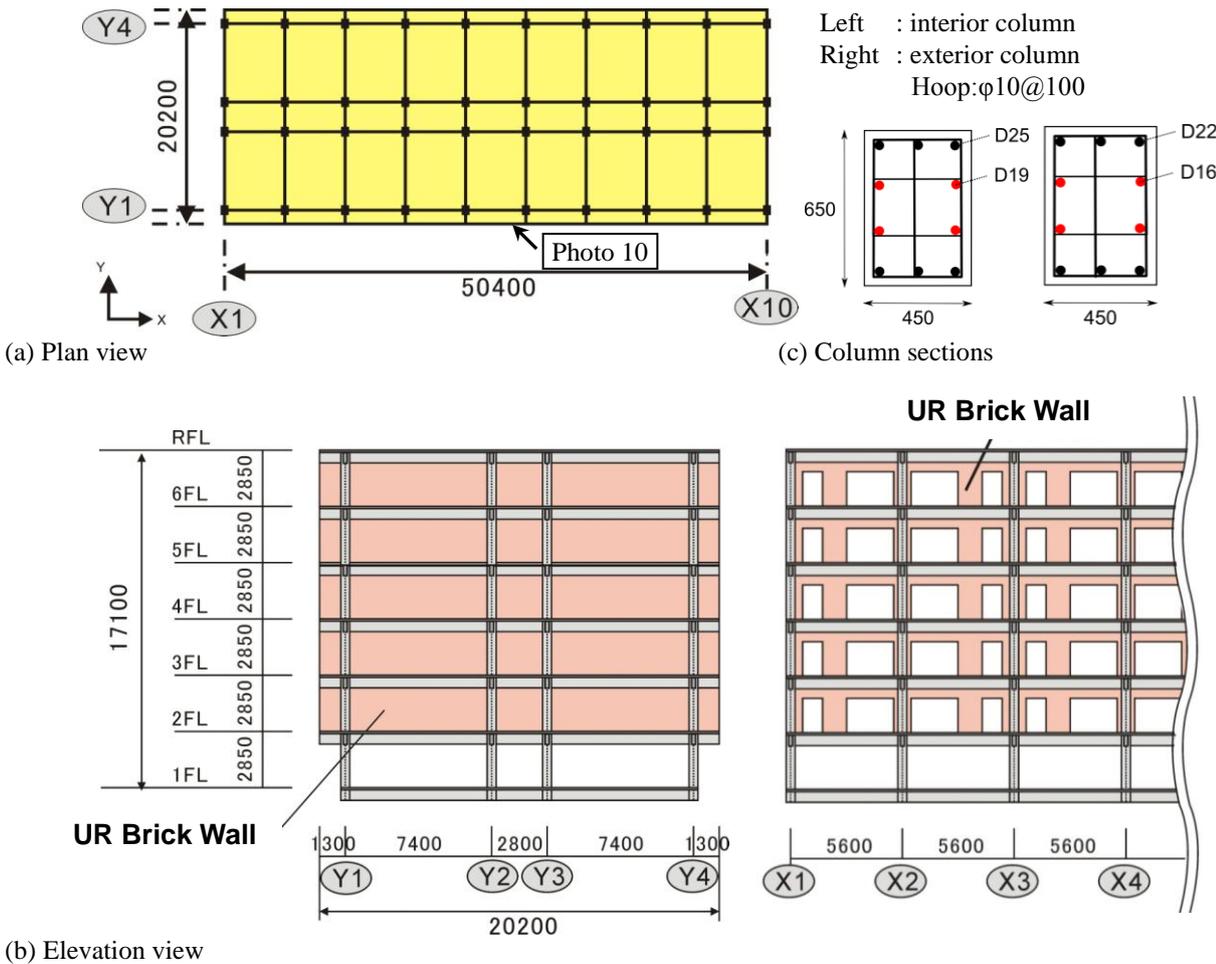
Figure 2. Structural configuration and column size of example RC building

The example building is a six story RC apartment building in Dujiangyan city, which appeared earlier in Photos 6 and 7. The building was under construction but its structural construction was already completed at the time of the earthquake. The first story designed for a parking garage has no walls, while the upper stories have dwelling units with UR brick walls as shown in Photo 10 and Figure 2.
