PERFORMANCE OF REINFORCED CONCRETE BUILDINGS IN THE 2016 KUMAMOTO EARTHQUAKES AND SEISMIC DESIGN IN JAPAN

ABSTRACT

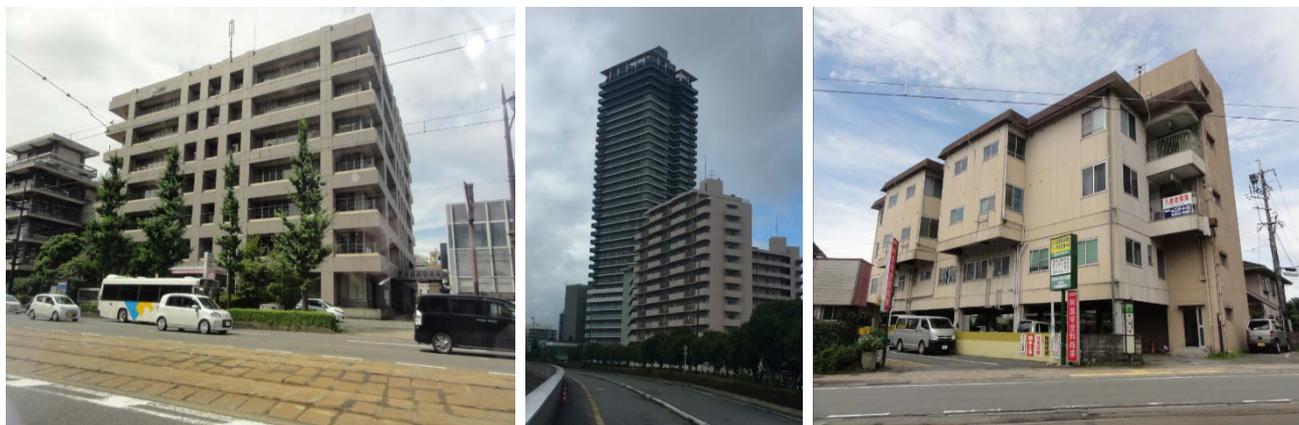
Figure 2: Example of multistory buildings with no damage.

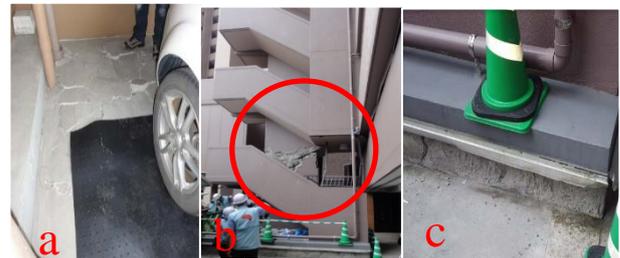
Figure 5: External damage to base isolated buildings (a) Base Isolated Building No.1 (Appendix A5) (b) & (c) Base Isolated Building No.2 (Appendix A6).

observed externally was minimal with the exception of shear failure of a stairwell wall which was concentrated between the first floor plane of isolation of the main structure and the base isolation of the stairwell at the ground level (Figure 5b). All base isolated buildings continued to be occupied after the earthquakes.

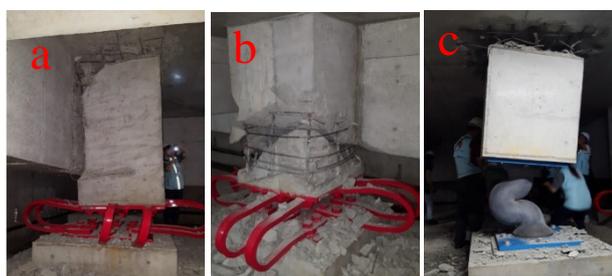
The reconnaissance team was given access to the basement of Base Isolated Building No. 1 (Appendix A5) to inspect the state of the isolation system of the structure. Observations of the damage (Figure 6) indicate that the building performed well, however due to some unconventional design choices, the damping system of the structure sustained heavy damage. The structure was damped using a combination of steel and lead dampers (refer to Appendix A5 for plan of isolation system and location of isolators). All base isolators were connected through a grid of concrete beams and no damage was observed to the isolators. The steel dampers were also connected into the concrete beam grid, however as shown in Figure 6, they were connected with an eccentricity which contributing to the damage sustained by the supporting concrete blocks. The lead dampers were completely excluded from the concrete beam grid and were simply connected to the concrete slab above by protruding concrete blocks. Most of the protruding concrete blocks for the lead dampers displayed similar damage to that shown in Figure 6 (c), where the concrete block-slab connection was completely lost.

Figure 6: Damage sustained to Steel (a) & (b) and lead (c) dampers below Base Isolated Building No. 1.

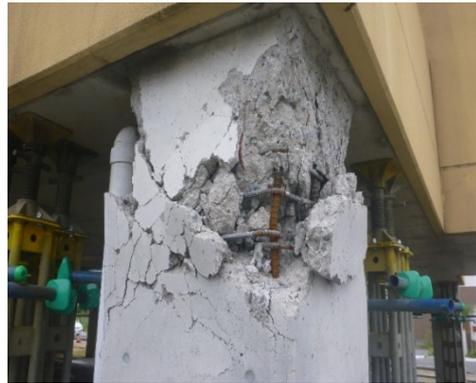
Photo 3: Column hinge and end wall footing spread

- The end transverse walls had formed horizontal cracks as a result of the wall folding against the Level 1 transfer slab. There was also noticeable spread of the wall base away from the building, indicating that the footings were not tied into the rest of the building foundation system.

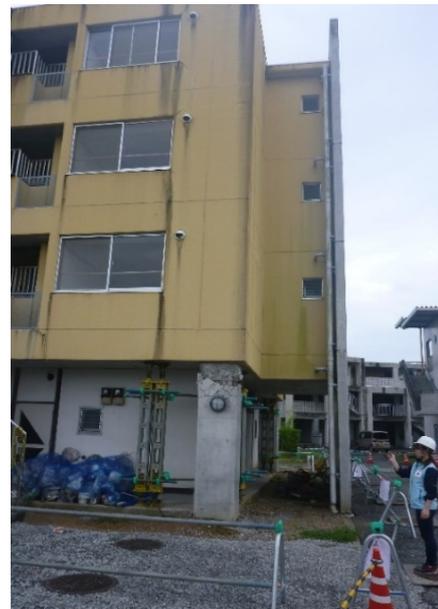
Photo 4: Plastic hinge at top of column.

- The damage observed from the outside of this building was limited to the ground floor only. All of the columns had formed plastic hinges at the top of the columns and very limited damage was observed at the column bases. Possibly there is column damage below ground level.

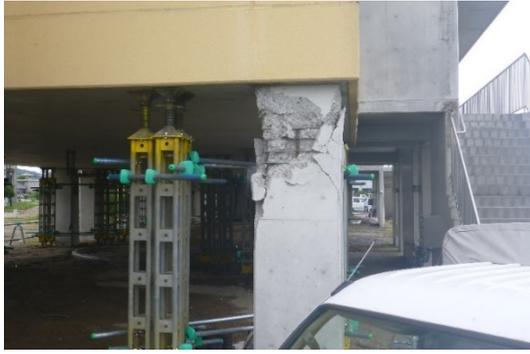
Photo 5: Column plastic hinge with intact concrete core.

- The column plastic hinges may be due to capacity design not being followed through completely with the interaction of the first floor transfer slab. There appeared to be bars terminated within the top of the ground floor columns, however it is uncertain if these are column bars or 90 degree bends from slab and beam steel. Generally the hinge was well confined, with the concrete core remaining intact, although vertical bar buckling was observed in many locations.

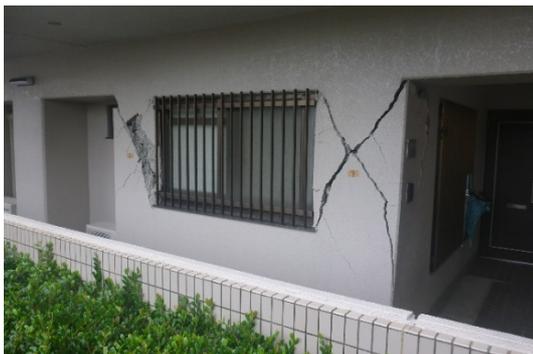
Photo 3: Typical infill concrete wall shear cracking due to interaction with moment frame beams.

- Within each moment-frame bay, 'non-structural' reinforced concrete infill walls were used to define windows and doors, however these were constructed to be integral with the moment-frames. Extensive shear cracking was observed in these elements.

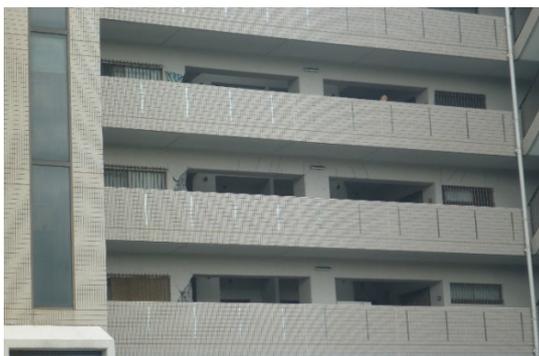
Photo 4: Moment frame beam flexural hinging in regions not affected by infill walls.

- Well distributed flexural cracks in some of the moment-frame beams, but no cracking in the columns or joint regions. This would suggest that the strong-column weak-beam design intent for the moment-frames was achieved where the infill walls didn't interfere with the frame response.

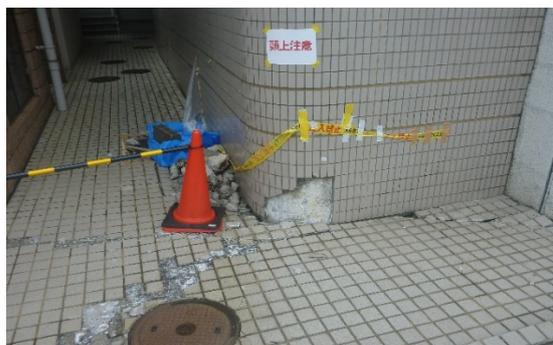
Photo 5: Foundation settlement at base of shear walls due to rocking.

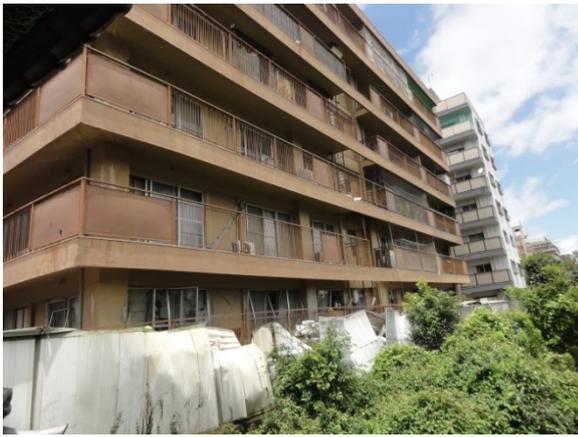
Elevation F

(note complete collapse of first story except near elevator core along street)

- Complete collapse of first story except along street.
- RC walls around elevator and stairs not structural (limited anchorage to foundation), but may have contributed to torsional response of building.
- No apparent structural walls in building.
- Most columns crushed and unable to identify mode of failure.
- Photos 1-3 show column with shear failure at base and joint failure – expect shear failure occurred first followed by joint failure when column slides down shear failure plane and is forced outward.
- Photo 6 shows damage to diaphragm near core (possible shear damage), but similar damage not observed at upper levels and thus believed to be damage induced by bending (or compression) of slab during collapse.
- Two similar buildings located next door and across the street did not collapse (Refer building summary A4 for description of building across the street).

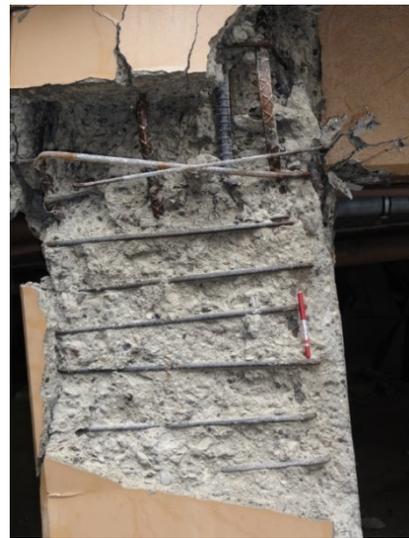
Photo 3

(smooth 10mm ties @ 100; no joint transverse reinforcement)

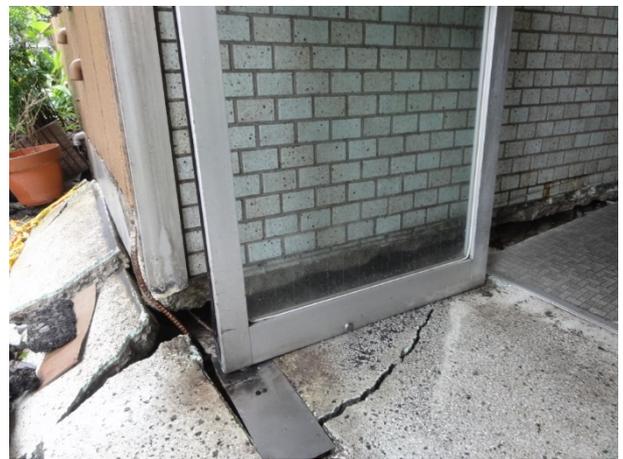
Photo 4: Uplift of wall (does not appear to be structural wall).

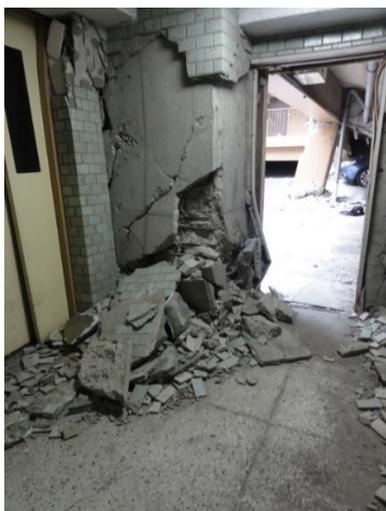
Photo 5b: crushed columns at corners of walls around core.

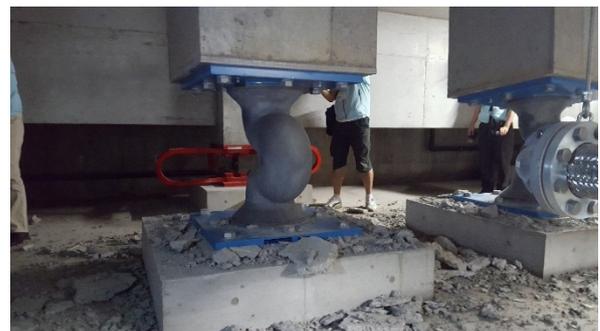
Photo 1: Lead dampers.

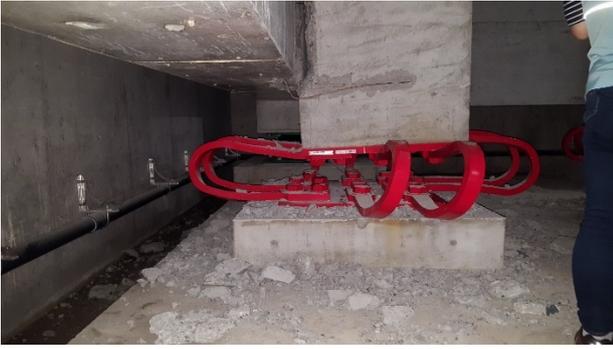
Photo 2: Steel dampers.

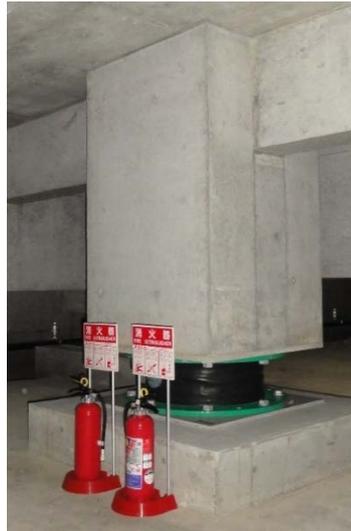
Photo 8: Small base isolator (see floor plan for location).

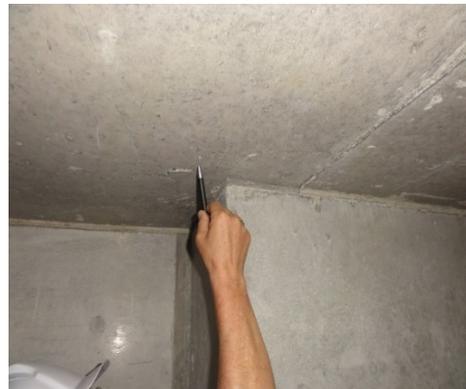
Photo 9: Visible signs of cone failure like cracking in base slab where small base isolator is connected.

- Some cracking was observed above small base isolation columns. This cracking was observed through the base slab in areas where there was access to inspect (refer Photos 9 and 10)

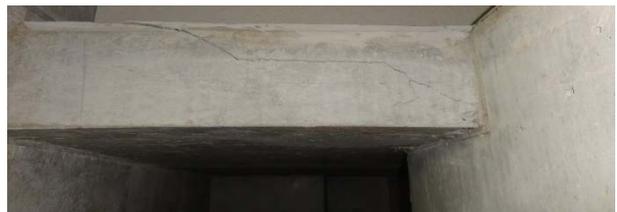
Photo 10: Cracking in deck slab where connected to small base isolator

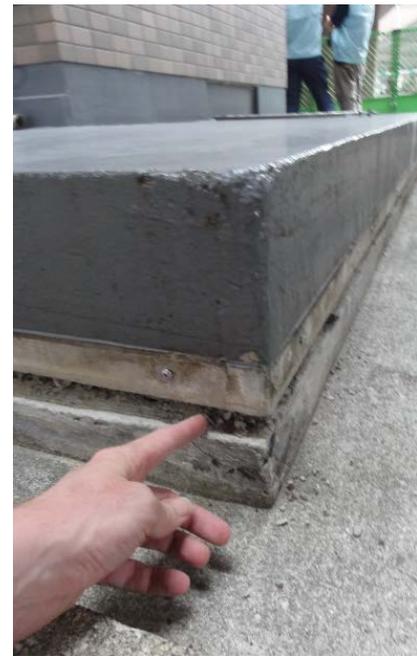
Photo 1: Evidence of residual displacement at base of building

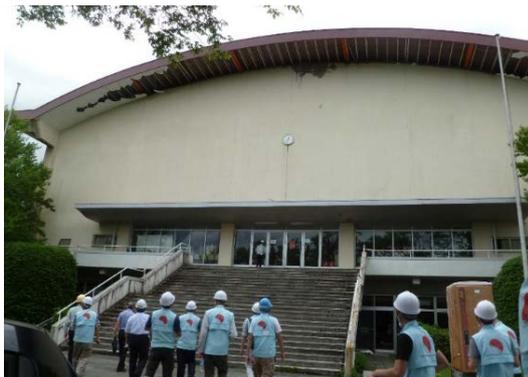
Photo 2: Building front exterior elevation (note damage to infill concrete walls and ceiling at roof interface).

- Loss of connection between the front end wall and the roof portal frame observed extending across at least the middle half of the end wall. The steel embedded connections had pulled out of the concrete. Resultant damage to exterior roof ceiling observed.
- Pounding of chimney and roof indicates movement of approximately 1.2m at roof level between the gymnasium roof and chimney.
- Shear damage to beams supporting mezzanine on side walls appeared to be limited to one beam location.
- Connection between roof trusses and concrete frame not able to be observed.
- No damage observed to hung lighting or other hung elements including basketball hoops supports except one light fitting partially unclipped.
- Building used as a shelter for approximately a week before damage assessment completed and damage identified.

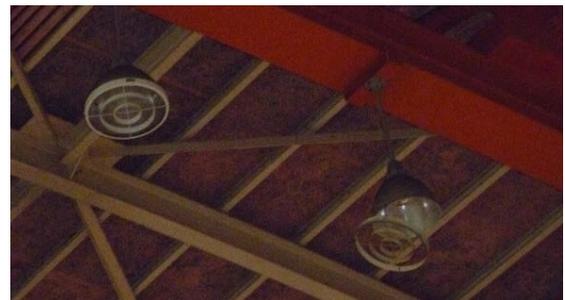
Photo 5: Light fitting partially unclipped.

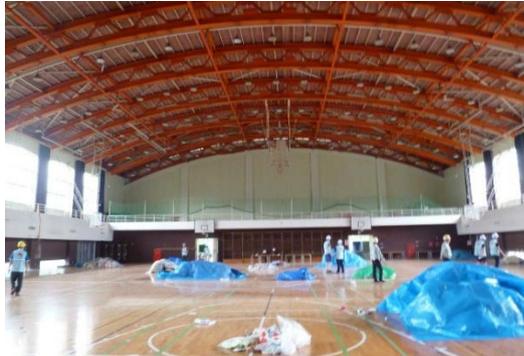
Photo 3: Building interior (note daylight at end wall roof interface).

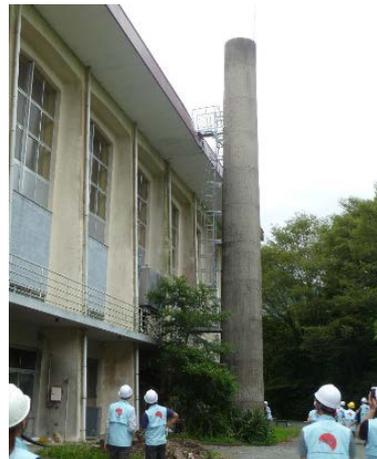
Photos 6 & 7: Chimney adjacent to building (note pounding damage at roof interface).

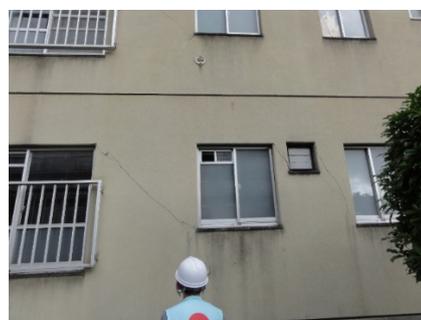
Photo 1: Cracking of non-structural walls due to differential settlement of building.

- Buildings 3, 4 and 5 were damaged and evacuated due to global building tilts of between 3 and 4%. These buildings are planned to be demolished and reconstructed.
- Damaged buildings had extensive disruption of soil immediately surrounding each building.
- Some limited cracking of non-structural walls due to differential movement observed.
- Buildings with seismic retrofitting performed well with no visible damage.
- Buildings 3, 4 and 5 are to be demolished and reconstructed.

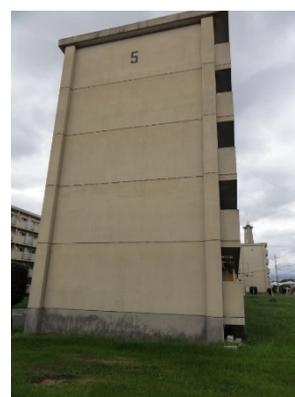
Photo 2: Visible leaning of Building No. 5 (One side noticeably lower than other).

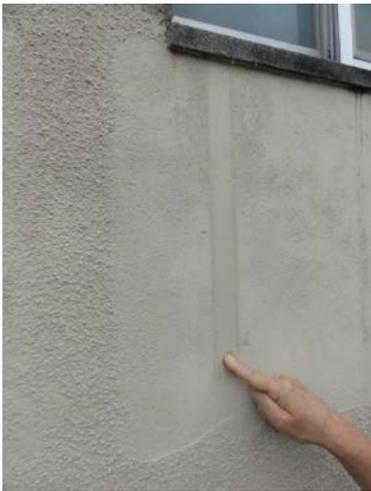
Photo 3: Separation of columns and non-structural walls as part of seismic retrofitting.

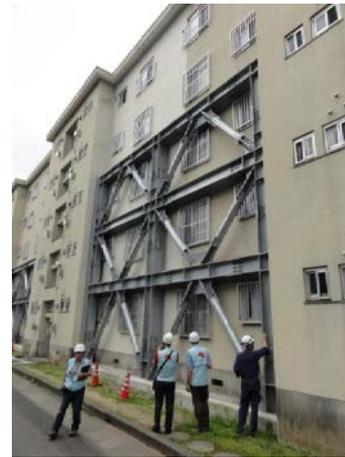
Photo 4: Seismic retrofitting of pre-1980 buildings.

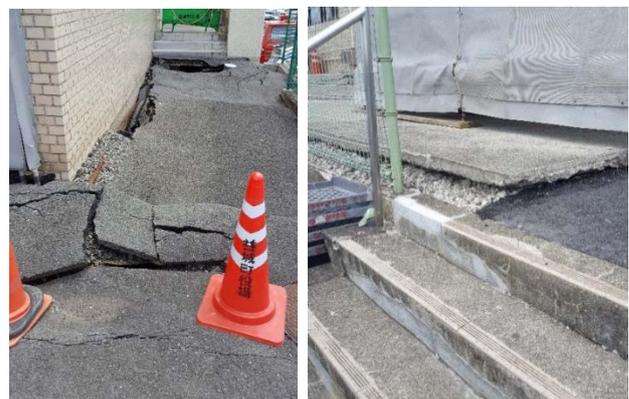
Photos 1 & 2: Ground subsidence around the building.

- Significant localised ground deformation observed around the building.
- Bridge Structure between two buildings shows signs of shear cracking in walls and also failure at joint between bridge and columns (refer Photos 3 & 4).
- Building retrofitted with additional concrete frame constructed on building exterior supported on separate piled foundations (refer building elevation).
- Post earthquake cantilevered roof and elevator on side of building have been removed and a new panel cladding has been installed.

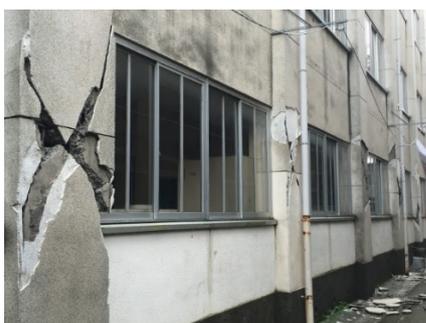
Photo 1: Damaged columns from outside the building

- Severe shear damage to the external columns on the corridor side. The cracks were typical of short column failure; i.e. x shaped cracks across the height of the window.
- No similar damage observed on the other side columns as the windows on the opposite side were taller. Also, the transverse shear walls were connected to the alternate columns in the other side, which further restrained the deformation (and hence damage) of the columns on the other side.
- Signs of plastic hinges about to develop at the ends of the beam in the extreme longitudinal frame in some of the classrooms.
- No major damage observed in the transverse frame/wall systems.

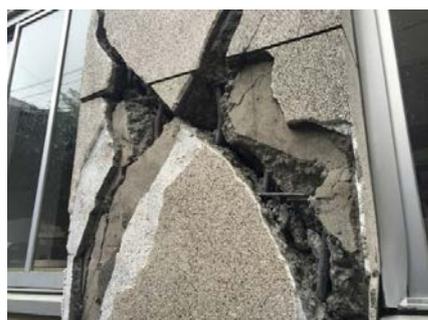
Photo 2: Close up view of typical columns failed in short column induced shear failure.

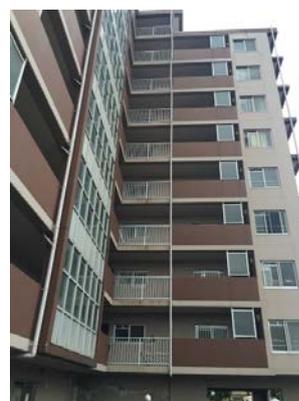
Photo 2: Building north elevation.

- The building was observed to have tilted in clockwise direction. Looking from the north side, the building had tilted to about 100mm at the top towards east. (Refer Photo 2 The number of railings crossing the edge of adjacent (left side) undamaged apartment confirmed the slight eastward lean of the building on this side.)

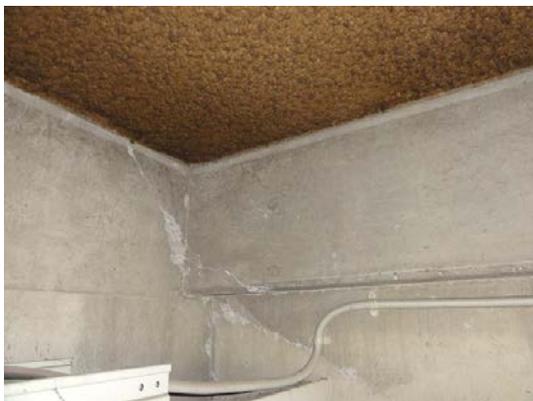
Photo 12: Close up view of the beam column joint at the NE corner from onside.

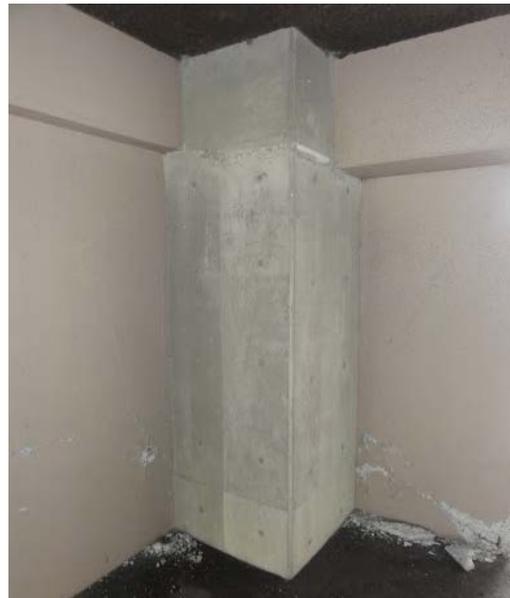
Photo 13: NW corner column and adjacent walls.

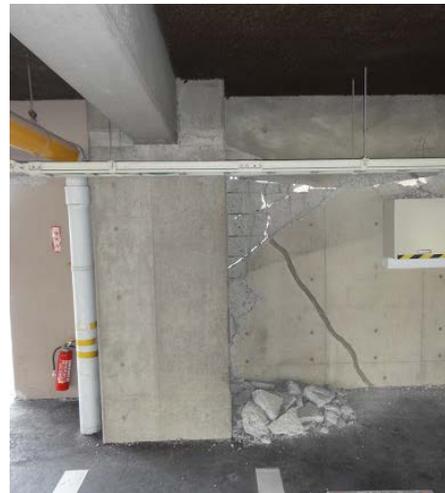
Photo 14: Column adjacent to the north entrance.

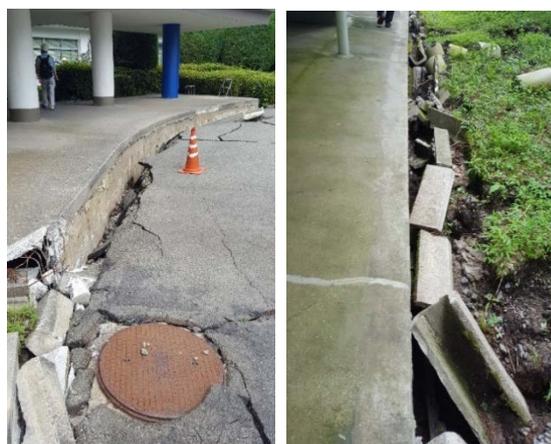
Photos 3 & 4: Ground subsidence around building.

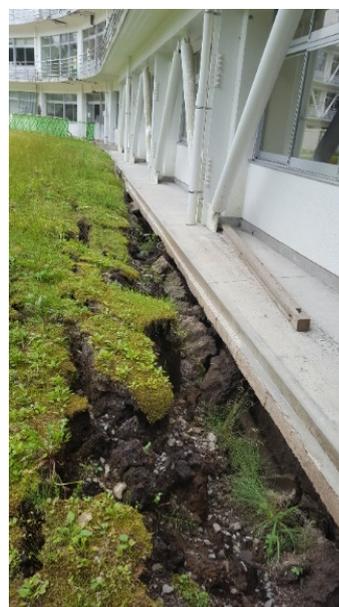
Photo 5: Ground subsidence around building.

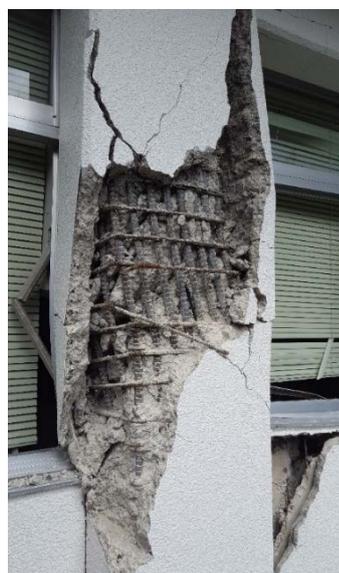
Photo 6: Shear failure of column at centre of building due to short column effect.

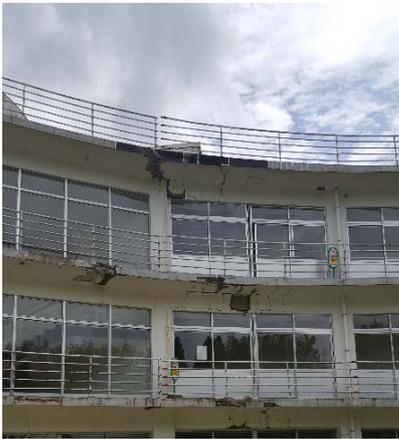
Photos 7, 8 & 9: Visible signs of damage at “Y” juncture of building.

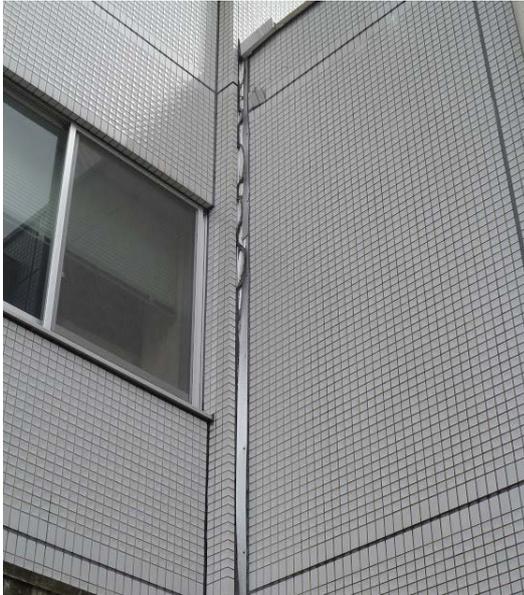
Detail A: Seismic joint between four storey block and interconnector at building exterior.

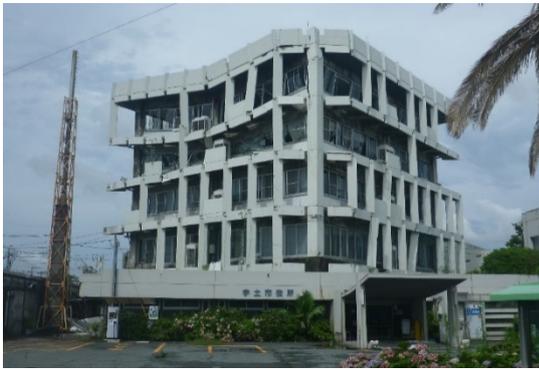
Photo 1: South-west elevation.

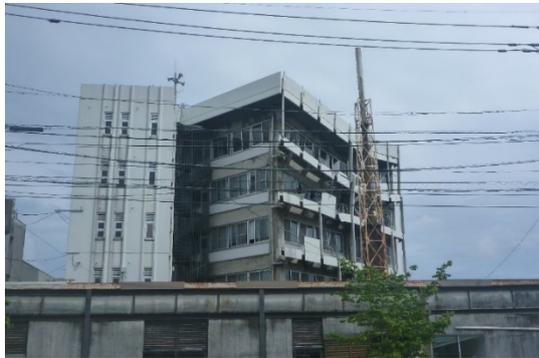
Photo 2: North-west elevation.

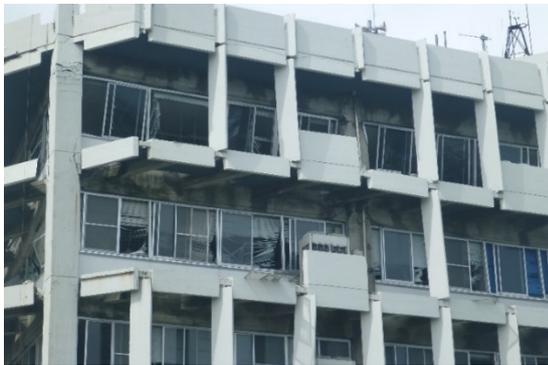
Photo 3: Column plastic-hinge at underside of roof beam and shear failure at Level 4 beam-column joint.

- This building suffered severe damage at the fourth floor, while relatively little damage was observed in the lower levels. The building has a very high plan eccentricity due to the services and stair core being located outside the main floor footprint, and attached at one corner of the floor plan.
- It is likely that the beam-column joint shear failure occurred due to accentuated deformation demands under the torsional plan response. Perimeter beam offset from the column centre-line and possibly poorly anchored reinforcement, either in the beam-column joint or from.
- An internal beam, may have allowed the perimeter beam on the south-west elevation to drop inwards from the column, resulting in the 1.5m floor settlement and outward lean of the upper floors to the south-west.
- This building was listed as a high priority for seismic retrofit prior to the earthquakes

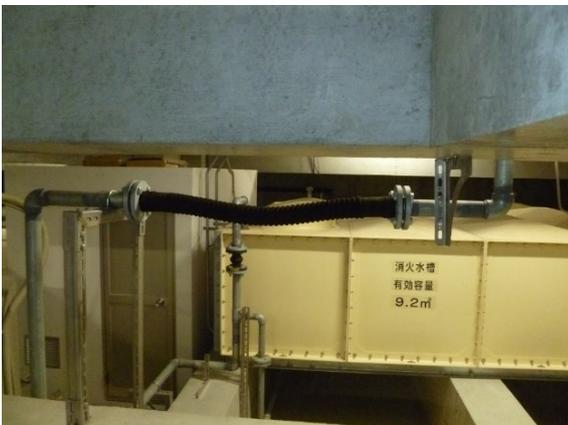
Photo 3: Building A5. Plant and piping in the basement located below the plane of isolation and flexible connectors across the plane of isolation.

- Major services plant located in basement below plane of isolation. Flexible pipe connections at all locations where plant crosses the plane of isolation with braced supports on each side of the flexible connection.
- Storm water plumbing appeared to be located entirely above the plane of isolation on hung supports.
- No damage observed to any of the plant or piping.

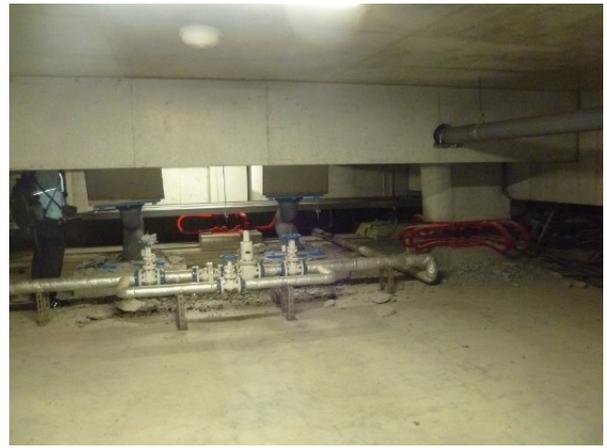
Photo 4: Building A5. Plant and piping in the basement located below the plane of isolation and flexible connectors across the plane of isolation. Note base isolation dampers in background.

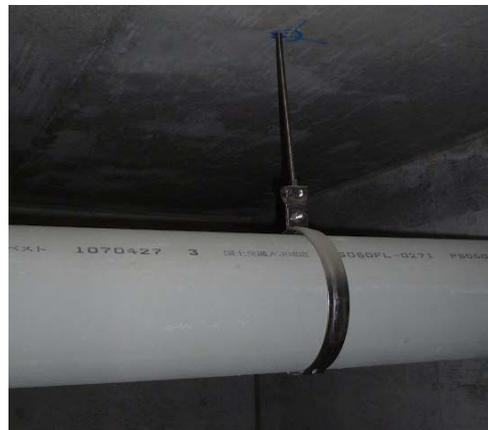
Photo 5: Building A5. Supports for storm water piping located immediately hung from ground floor above the plane of seismic isolation.

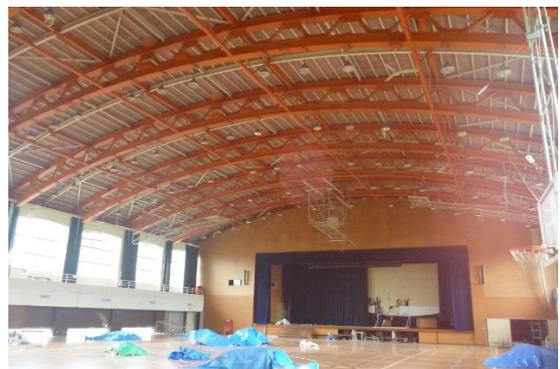
Photo 6: Building A7 designed with no ceiling thus avoiding damage

- Damage to exterior soffit where end wall of the building separated from the roof structure. No ceiling on building interior.
- Detail of lights hung from roof structure indicating one light fitting that has become partially unclipped, assumed to be resulting from earthquake movements.

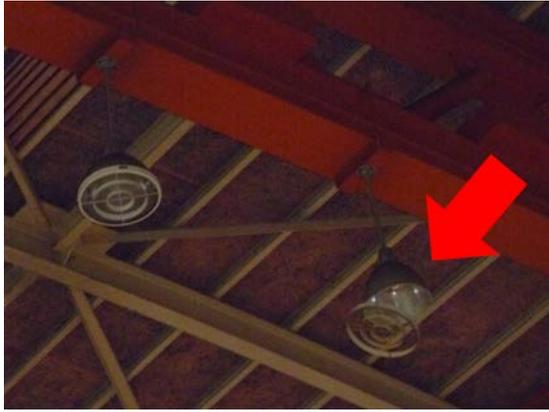
Photo 7: Building A7 detail of ceiling.

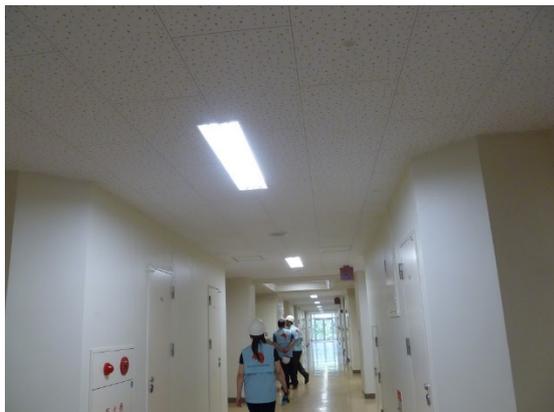
Photo 9: Building A14 building internal ceiling, no damage observed

- No damage observed to ceilings or hung services.
- No fire sprinklers observed.

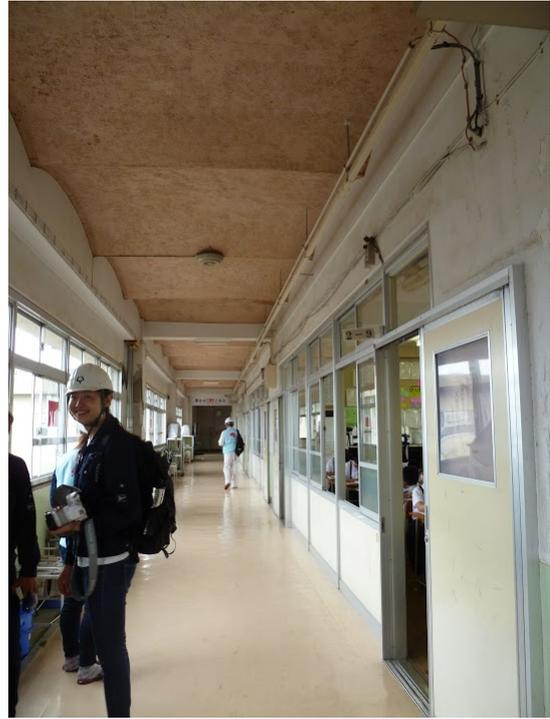
Photo 10: Building A10 classroom corridor.

- No hung ceiling.
- Acoustical protection applied directly to underside of concrete floor structure. No damage observed to hung services.

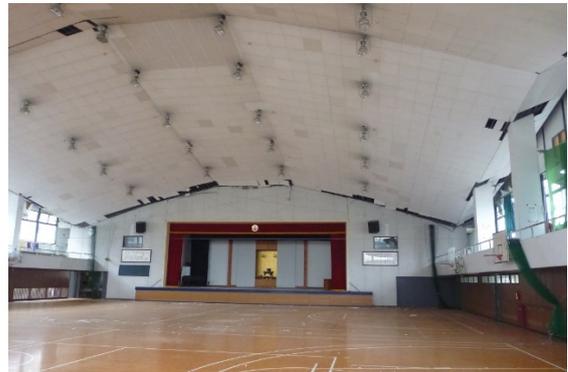
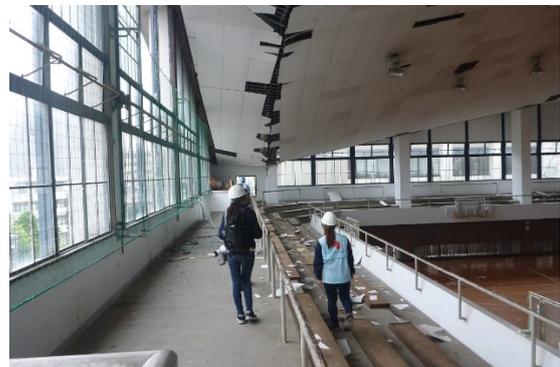
Photos 11 & 12: Gym close to Building A10.

- Suspended ceiling damaged at changes in orientation and adjacent to structural end walls and columns. No damage observed to hung services e.g. lights.
- No fire sprinklers observed.
- Note damage at change in ceiling orientation

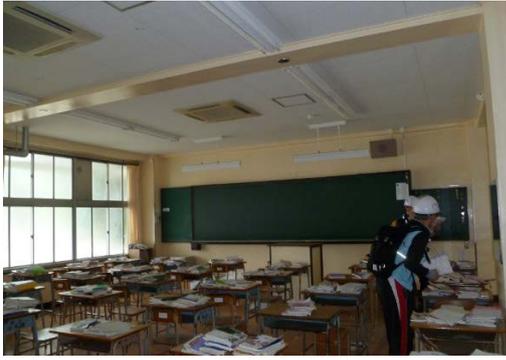
Photo 13: Building A11.

- No damaged observed to ceiling or hung non-structural elements. Ceiling appeared to be rigidly adhered to the concrete floor structure above.
- No fire sprinklers observed.

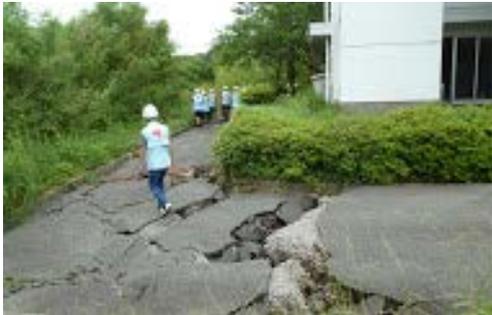
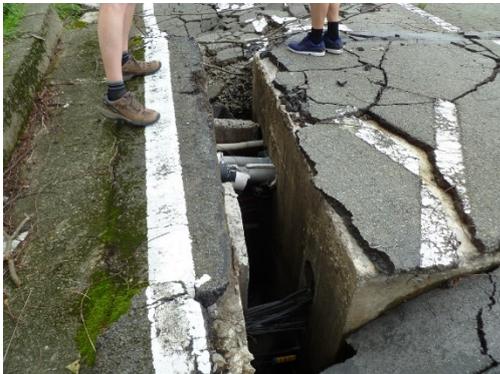
Photos 14 & 15: Ground and underground services disruption Building A13.

- Significant ground rupture observed in the area of the dormitory resulting in significant damage to underground services particularly at junctions between pipes and cast in place concrete chambers and concrete foundation pads.

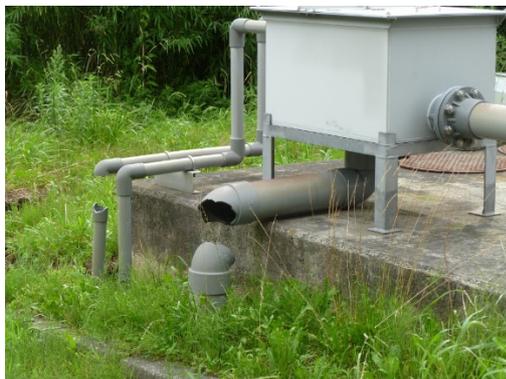
Photo 16: Broken piping adjacent to Building A13.

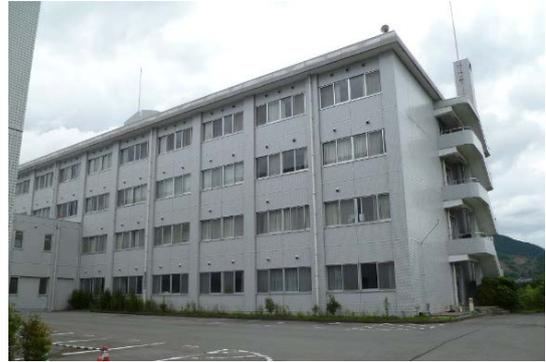
Photo 17: Building A14. Exterior covered in ceramic tiles applied directly to the concrete structure. A typical Japanese cladding system

- No damage observed to building cladding system.

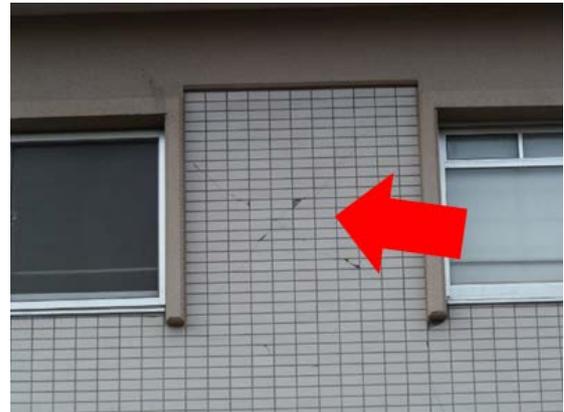
Photo 18: Building A12, Exterior tiled cladding.

- Cracking in cast in place concrete wall elements (considered to not be part of the lateral load resisting structure evidenced in the exterior tiles.

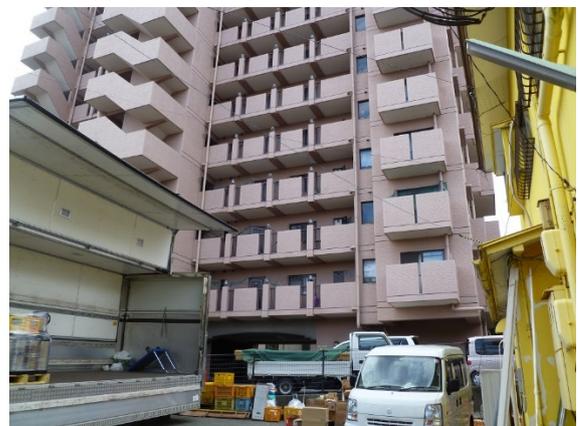
Photo 19: Apartment buildings Kumamoto. Undamaged buildings.

- Note separation joint in concrete balcony balustrades to allow movement without damage to building.

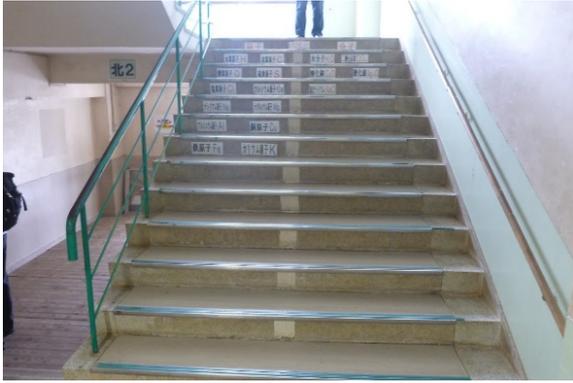
Photo 20: Building A10 no damage observed to stairs.

- Stairs constructed in reinforced concrete, no sliding joints observed.

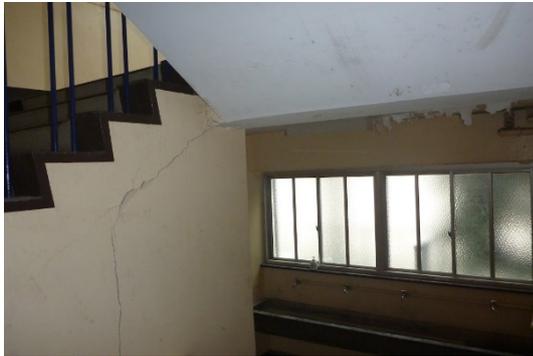
Photo 21: Building A11.

- No damage observed to stairs, minor cracking to non-structural wall below stairs.
- Stairs constructed in reinforced concrete, no sliding joints observed.

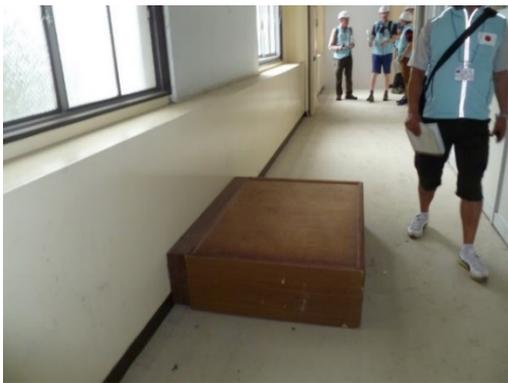
Photo 22: Building A10.

- Bookcase laid down in school corridor to prevent possible falling in any aftershocks.

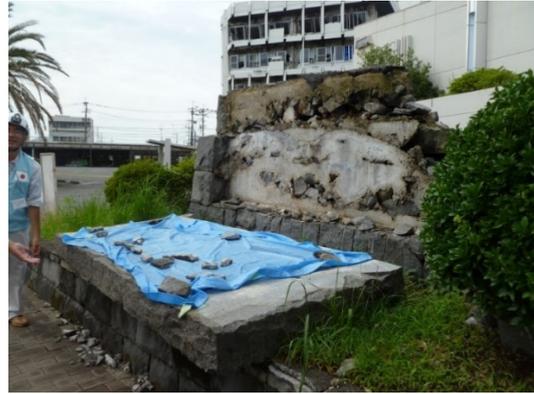
Photo 23: Building A13 exterior signage.

- Limited mortar joint affixing stone signage to wall.

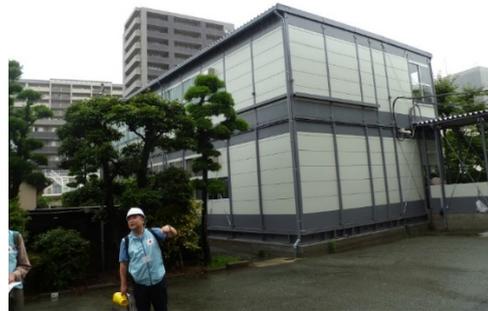
Photo 24: Building A11, Temporary school administration block.

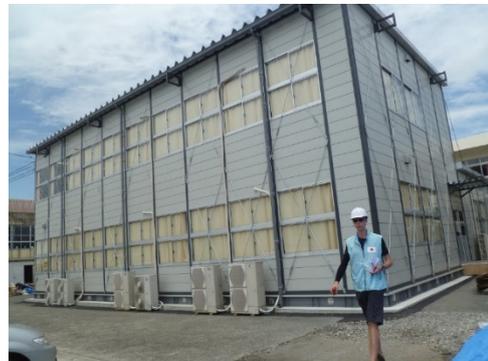
Photo 25: Building A15, City Hall temporary office block erected on carpark adjacent to the damaged buildings they are temporarily replacing

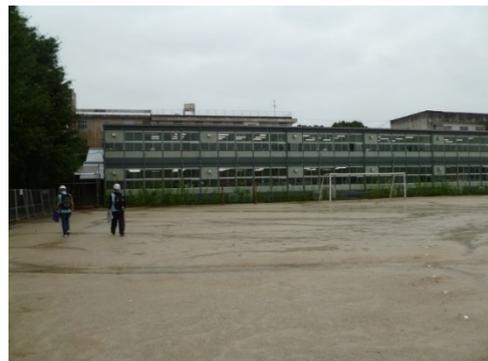
Photo 38: Building A11,, Temporary class room block erected in school playing field
